No. 92-20

## A. ALPHA ONE/ALPHA ONE GENERATION II R/MR GEAR SETS

All stern drive models using the following gear sets 43-18411A2/43-45814A5/43-55778A3/43-75325A3

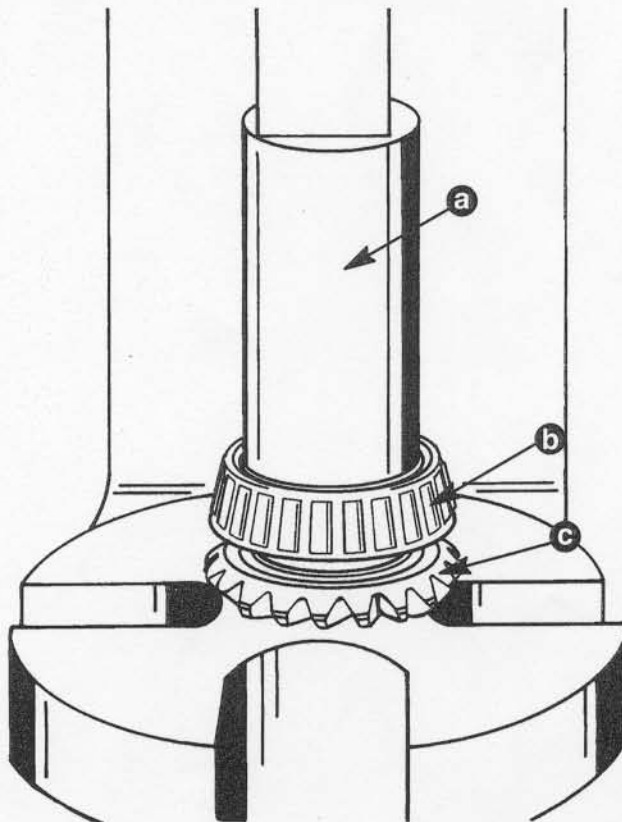
22393

1. Press the first bearing cone onto drive gear until it is firmly seated.

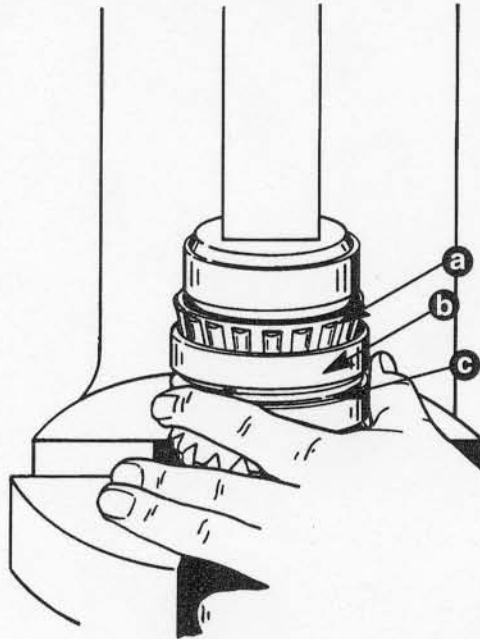
22393

3. Press the second bearing cone onto gear until the rollers just contact the cup.

NOTE: If a slight over-press condition occurs (spacer does not move freely) - support second bearing cup with universal puller plate and lightly tap end of gear with a soft hammer. Failure to do this will result in a high initial preload when you check it in the following steps.

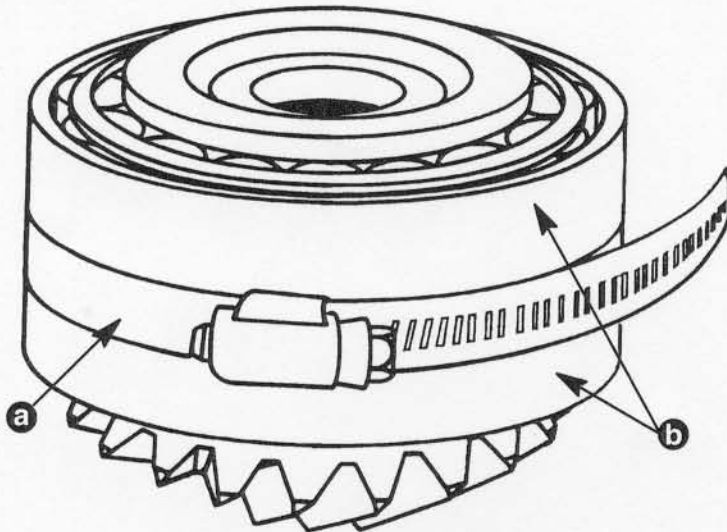
70092

4. Temporarily install a hose clamp on the bearing assembly to keep the bearing cups and cup spacer centered, prior to adjusting the preload.

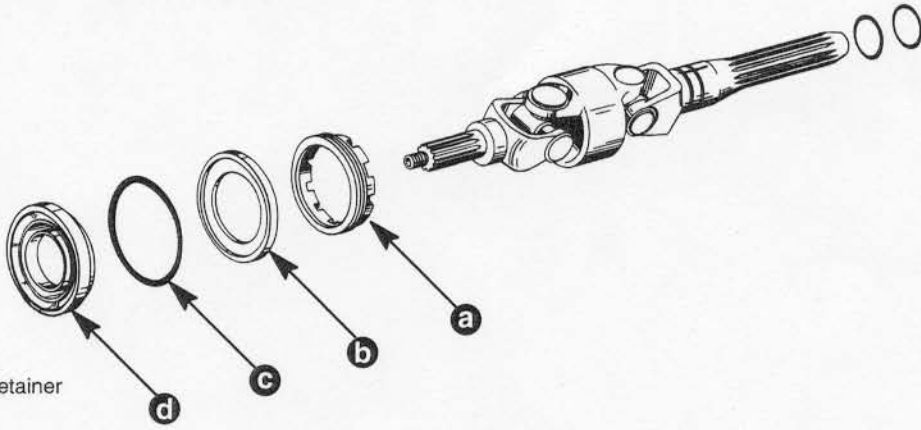
23010

5. Install remaining components in order as shown.

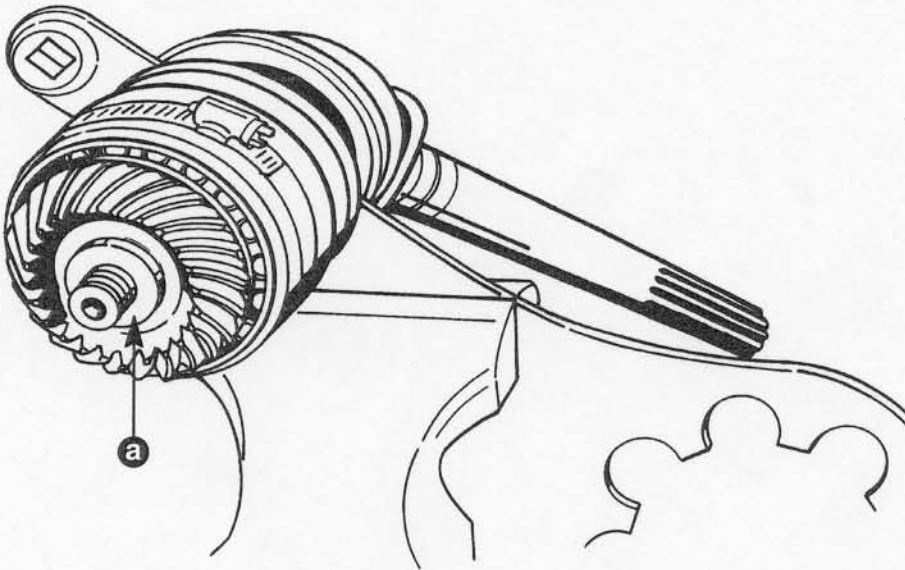
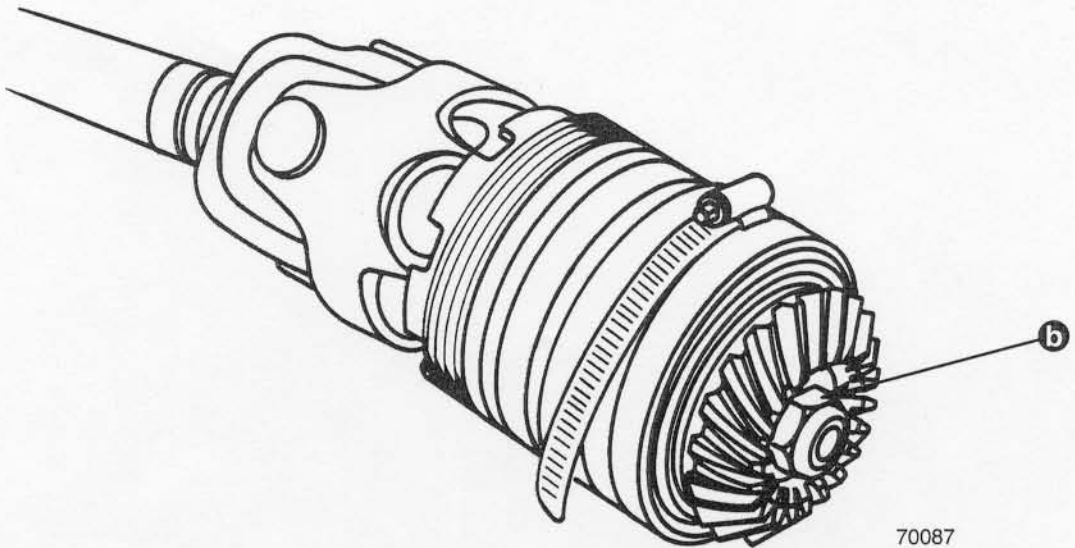
6. Install drive gear and bearings onto u-joint shaft. Secure with washer and locknut. Tighten until locknut just makes contact with washer.

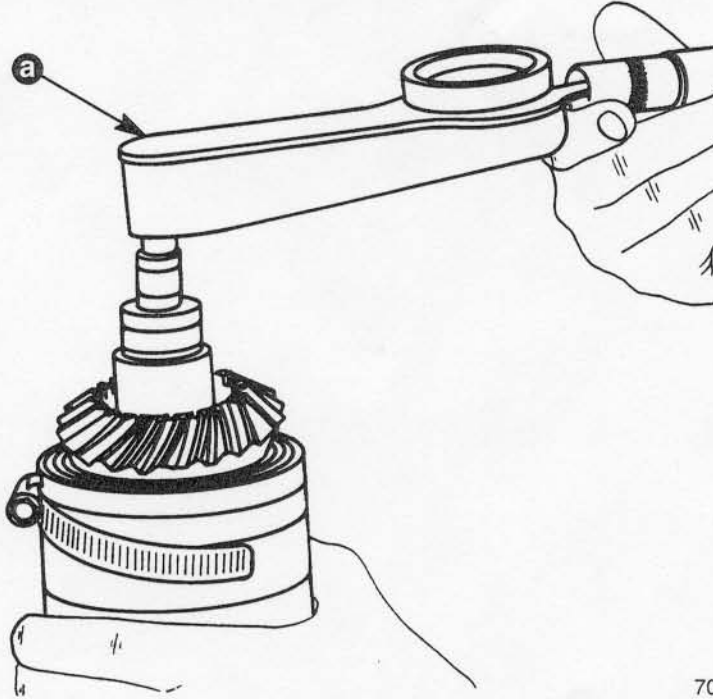
70086

7. Set preload by tightening nut 1/16 of a turn at a time. Check for proper preload by turning gear using a torque wrench, until a 6-10 lb. in. (0.7 - 1.1 N-m) torque is obtained. If nut is accidentally overtightened (causing excessive preload), it will be necessary to loosen the locknut, and lightly strike the gear and bearing assembly to loosen the preload. You should then repeat this entire procedure.
