# service bulletin

No. 93-9

# A. NEW REVERSE GEAR 43-824109 AND THRUST SPACER 23-824108

McI / Alpha One / Alpha one Generation II

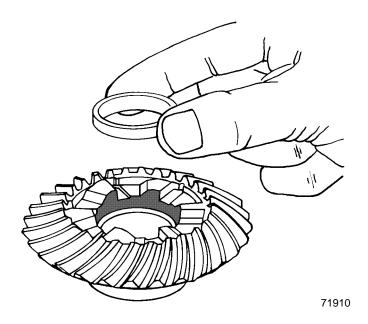
The reverse gear has had a machining change to accommodate for a thrust spacer to eliminate wear between the propeller shaft at the collar on the splined area of the shaft and the gear.

43-824109A1 Reverse Gear Kit which includes the spacer with the gear.

When installing the new gear it may be necessary to replace the prop shaft if the collar on the shaft at the aft end of the clutch spline area is worn and or discolored from wear.

When installing follow the installation instructions that come with the gear kit.
