**No. 93-14**

## Weber 4 Barrel Carburetor

### Adjustable Accelerator Pump

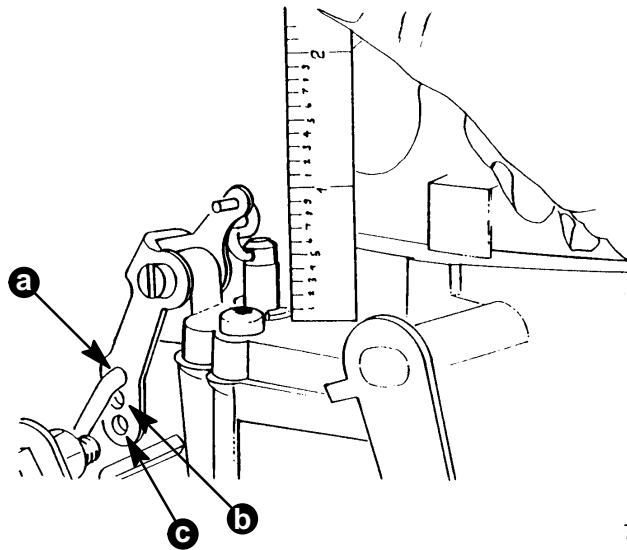
70472

The accelerator pump lever has three holes in it. The closest hole to the lever's pivot point is the richest, the second hole is leaner and the hole farthest away is the leanest. All production carbs have the pump rod installed in the closest (richest) hole. If you are having a "rich" bog on acceleration, move the rod to the second or third hole. Weber put the three holes in the lever so the amount of fuel delivered by the accelerator pump could be changed.

- a - Richest
- b - Leaner
- c - Leanest

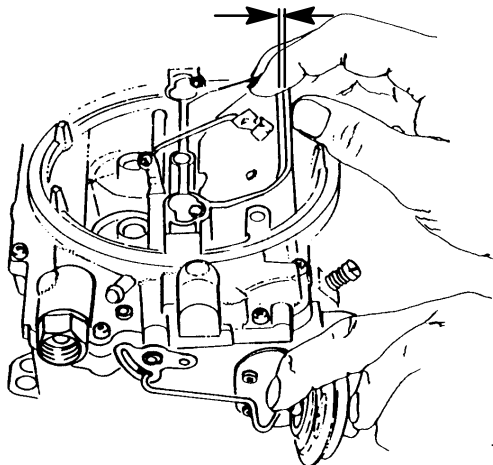
70471

Whenever servicing one of these engines or if your customer is experiencing an overly rich running condition after first starting the engine, please reset the Choke Pull-Off to this new specification.

V6 & V8 305, 350 cid: 3/16 in. (4.5 mm)
V8 454, 502 cid: 15/64 in. (6 mm)

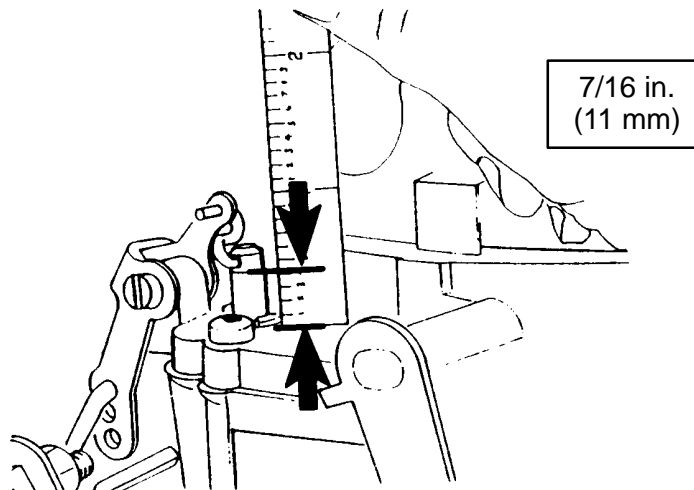
Check the accelerator pump height, after you have made the idle mixture and RPM adjustments on a warmed up engine. If this isn't checked after the idle adjustments are made, the pump may not be getting its full stroke which could cause an acceleration "bog".

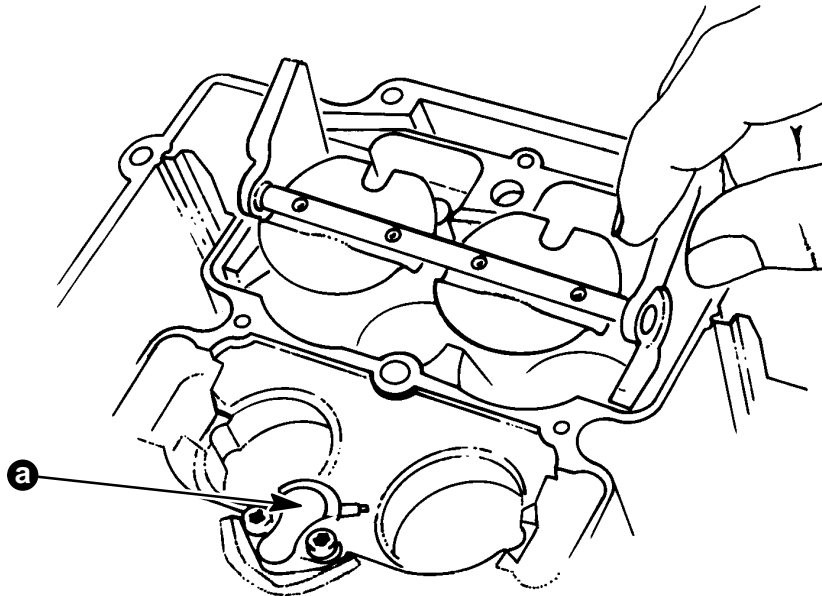
70459

Watch the carburetor's pump jet housing nozzles while operating the throttle. Fuel should be coming out of both nozzles. If it isn't, there's the problem. The two most common reasons for this problem are, accelerator pump failure or a stuck check ball in the passage below pump jet housing.

a - Pump Jet Housing. Check Ball Is In Passage Under The Housing.

Remove top half of the carburetor to inspect the accelerator pump. Repair as required. Remove the pump jet housing. Make sure the check ball, in the passage under the housing, is not stuck. If it is, use a pick to loosen ball up. Clean check ball and reassemble.
