**No. 93-15**

**NOTICE: The information contained in this Service Bulletin supercedes all previous bulletins, including 92-6.**

## Rochester 4 Barrel Quadrajet Carburetor

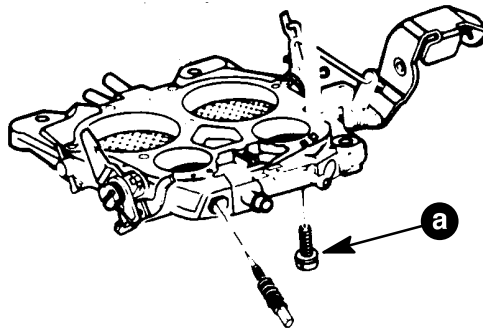
**Figure 1.**

Possible cause could be air leak through carburetor mounting gasket. This gasket may leak in the area of the screw that holds the throttle body to the float bowl. This screw (a) is in a hole in the base of the carburetor, on the throttle lever side (Figure 1.). Because of this hole, the gasket may not be making an air tight seal. Remove carburetor from intake manifold. Inspect gasket to see if it has covered screw hole completely to seal out air leak. Do not remove screw, just fill screw hole with a silicone sealer. Using new mounting gasket, install carburetor. Torque carburetor mounting nuts and bolts to 20 lb. ft. (27 N·m).

(1) 27-52457--2 Mounting Gasket

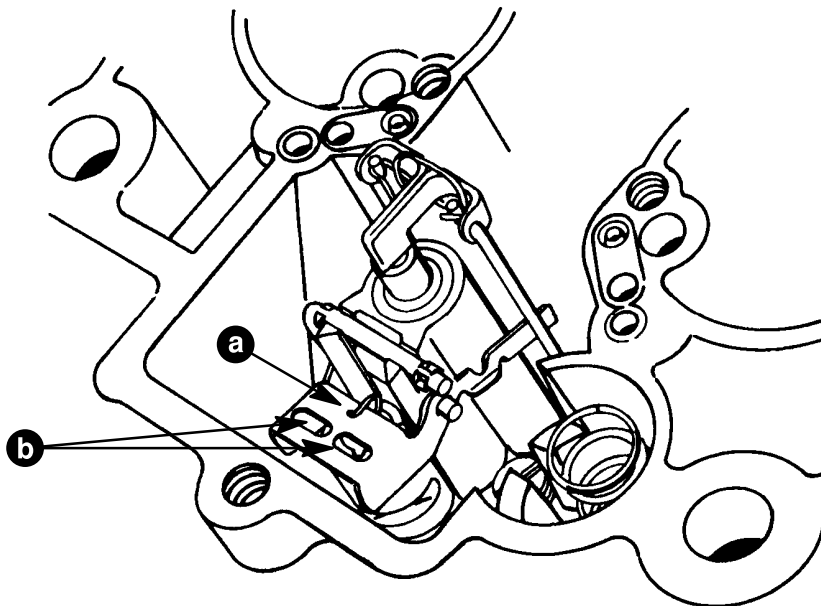
70818

When removing the air horn from a carburetor for this problem, look at the pull clip for the needle. This pull clip must be hooked over the end of the float arm, not in the holes. If the clip is hooked in either hole, the needle will not seat properly. This could be the reason for the flooding problem.

a - Hook Over End of Float Arm  
b - DO NOT Hook in These Holes

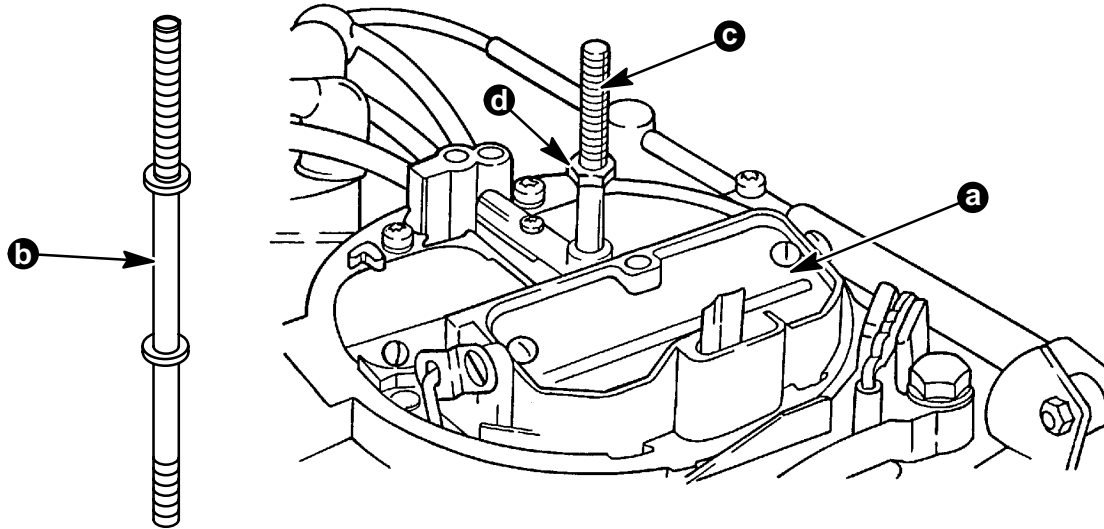
74570

We have had some reports of this engine being down in power above 3000 RPM. To correct this problem, do the following;

1. Reset the secondary air valve (a) spring windup to 60 grams.
2. Replace the “stepped” flame arrestor stud, (b). Replacement stud doesn’t have “step”. The “stepped” stud could cause the secondary air valve to stick partially closed.

16-91842 Stud, (c).

11-28941 Nut, (d), to take the place of the upper step so flame arrestor doesn’t get over tightened.
