No. 93-24

A. BRAVO THREE BEARING CARRIER OIL SEALS

BRAVO THREE DRIVES (ONLY)

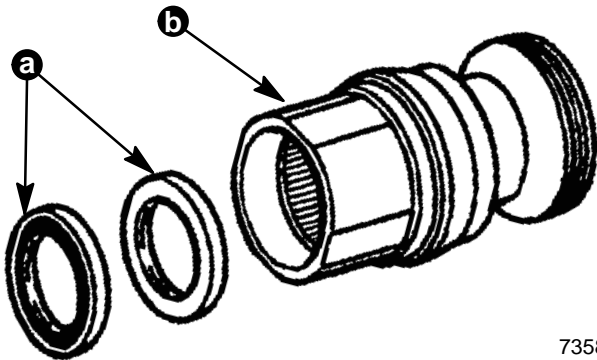
73585

Bearing carrier oil seal, The rubber seal may be loose in the steel casing and could cause oil to leak from the outer propeller shaft area and also may allow water to leak into the drive unit, In either case this could cause damage to the drive unit, and they should be replaced.

a - Oil Seals (2)

b - Bearing Carrier

Follow the repair procedures in service manual Number (11) section (3D) Gear Housing Repair.
