**No. 93-28**

## A. DHB Power Steering Valve (806034A1)

All Alpha One Generation II/ Bravo One/Two/ Three/ and 502 EFI Black Hawk (1994 product only).

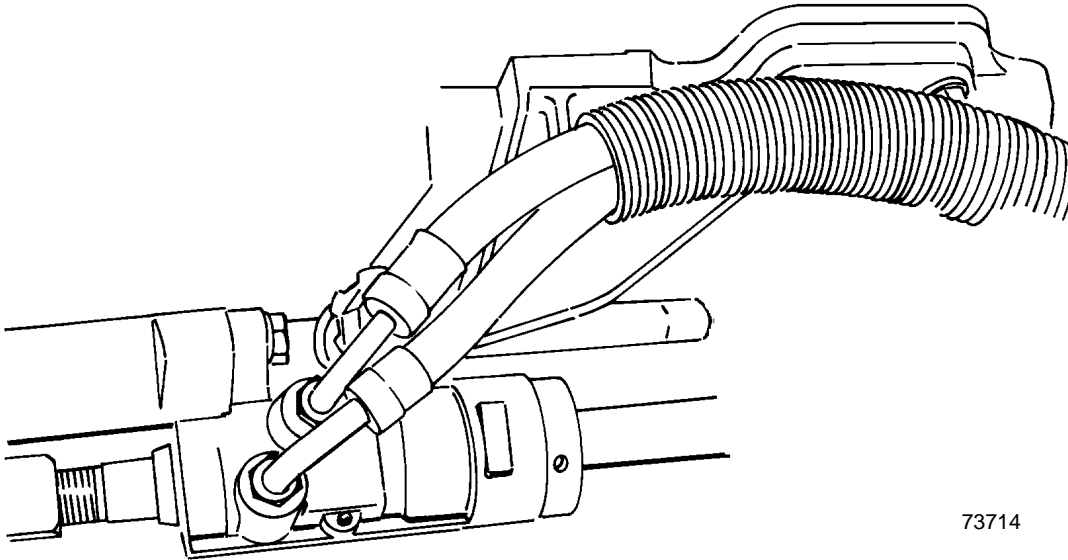
figure (1)

Figure 1 above is for the 4.3 L / 4.3 LX V-6 only later models.

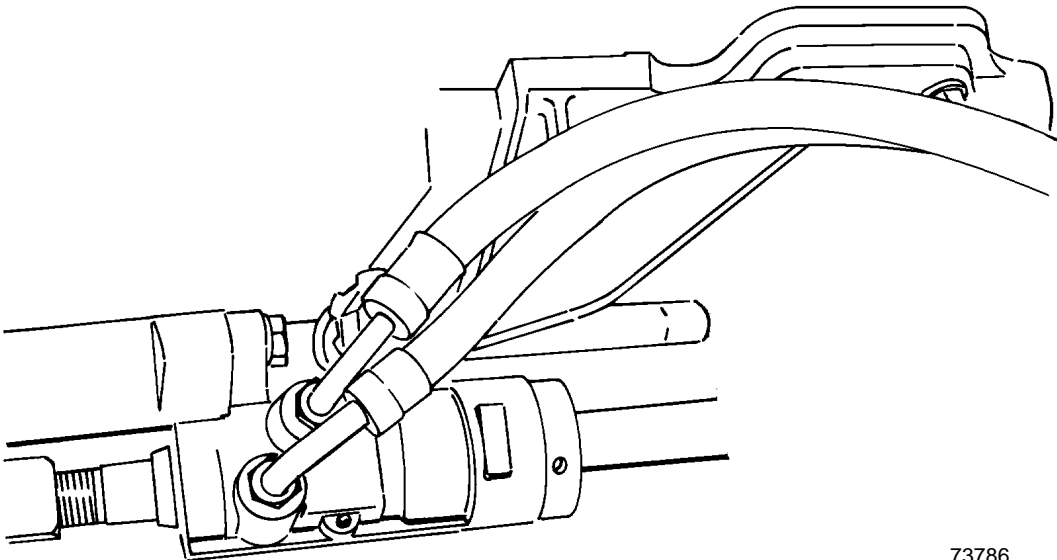
figure (2)

Figure 2 above is for the 3.0LX / 5.0L / 5.0LX / 5.7L 350 Magnum / 7.4L / 454 Magnum / 454 Magnum EFI, also earlier (94) 4.3L and 4.3LX and (early 502 EFI models with oil cooler return lines on the port side of the cooler).

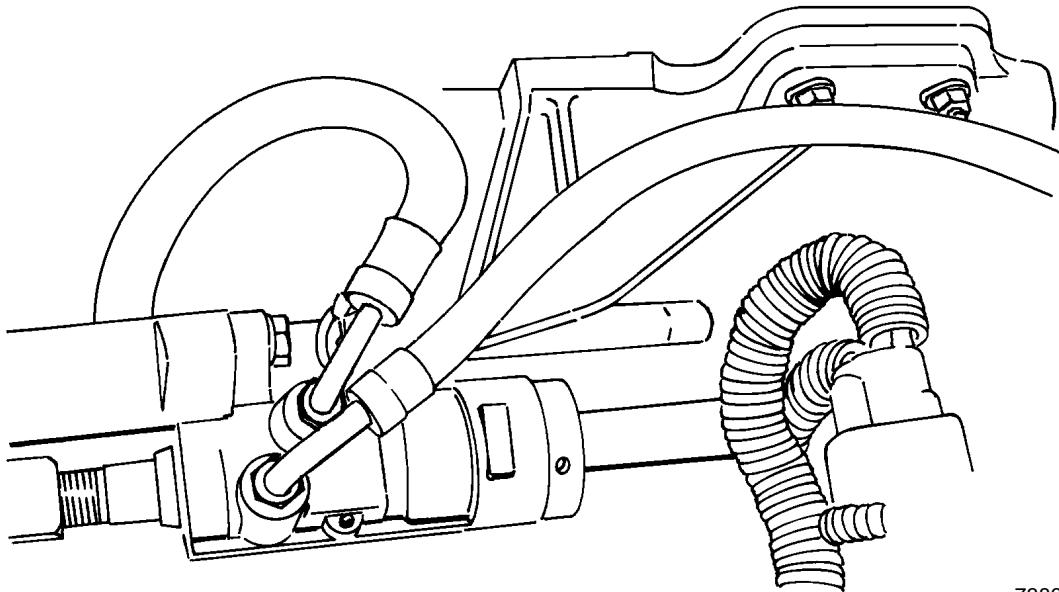
figure (3)

Figure 3 above is for the 502 EFI with oil cooler return lines on the starboard side of the cooler. The following chart may be used to record the values taken.
