## 3.0L Engines with Blown Head Gasket

▲1997 3.0LX Sterndrive Engines: S/N 0K001529-0L000000.

1998 3.0L Sterndrive Engines: S/N 0L000001-0L097000.

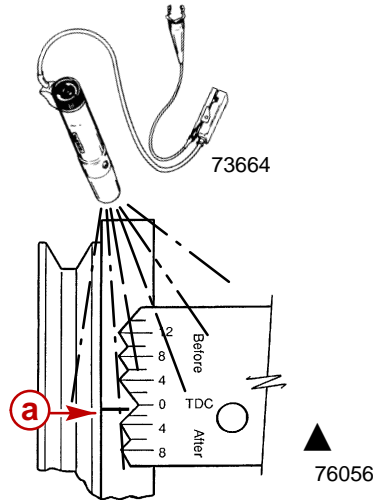
**a** - Timing Mark At 1° ATDC (After Top Dead Center)

5. Reset repaired engine's initial timing to 1° ATDC.
