▲ = Revised May 2000

Sensor Failures in MEFI-3 Mercury Distributors Used on V6 and V8 305/350 cid Engines

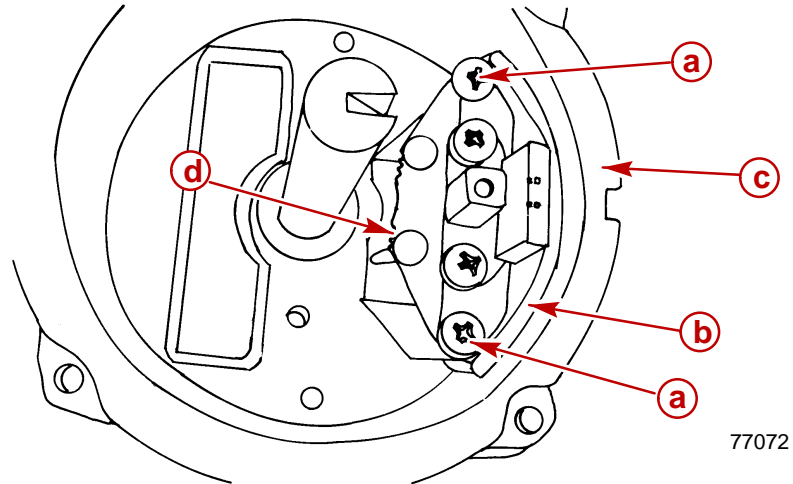
We have had some failures to the gray colored sensor in the distributor. A new sensor for use in the MEFI-3 distributors is now in production and in Mercury Parts stock. The color of the new sensor's material is black.

Two common ignition problems reported with these sensor failures are: a 'no start condition' or a 'rough running condition'.

▲ **IMPORTANT:** To make sure that the 'fingers' on the rotor/sensor wheel do not touch the sensor when the engine is cranked, follow the directions below.

▲ During installation, push sensor outward until the rubber gasket is slightly compressed against the distributor housing then tightening the sensor mounting screws
