Bulletin No. 2002-11

Uneven or Increased Handle Effort After Control Installation – Commander 3000 Classic Panel Mount Remote Control

Commander 3000 Classic Panel Mount Remote Control

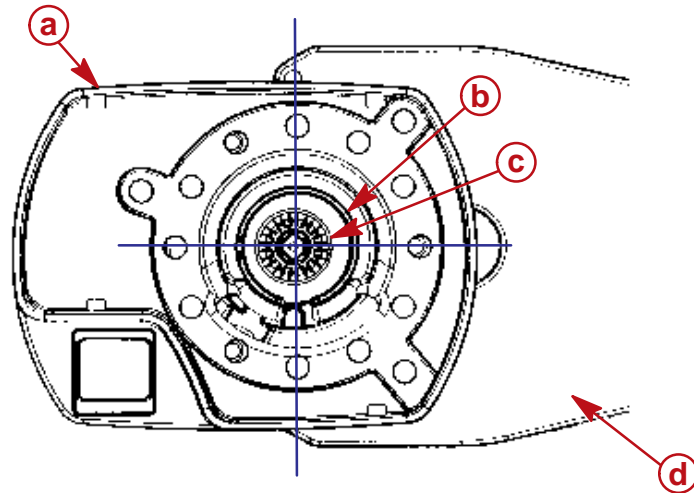
Misaligned Condition

If the amount of effort required to shift the control handle of an affected Commander 3000 panel mount control seems high or feels uneven (easier to shift from neutral to forward or from neutral to reverse and then harder in the opposite direction), the control's bezel may have been misaligned during installation. This condition may be caused by tightening the remote control module to the bezel plate with the remote control handle shaft not properly centered in the bezel plate hub opening. This may occur if the handle is placed into the bushing and bezel opening with the brass handle retaining nut tightened to 17 Nm (150 lb-in.). The handle hub may then rotate in a slightly non-concentric manner, causing the handle to drag or bind in one direction but not the other. If this misalignment condition is extreme, the handle may feel tight in both directions.

- a** - Bezel
- b** - Handle Hub Opening
- c** - Handle
- d** - Remote Control Module

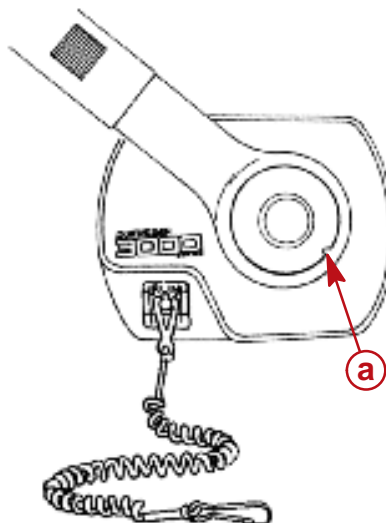
74411

a - Control Handle Friction Screw Location

NOTE: Verify that the control handle friction screw located on the hub of the bezel plate is backed off before checking for this condition.

With the shift and throttle cables disconnected from the engine end, rotate the shift/throttle handle to the full throttle positions (both forward and reverse), feeling for handle rotation that is even in both directions. If the handle effort is higher in one direction over the other, remove the throttle only button and the handle nut. Pull off the control handle then remove the bezel cover plate. It is not necessary to remove the trim wiring, just pull the handle assembly out from the bezel and leave the wiring connected.

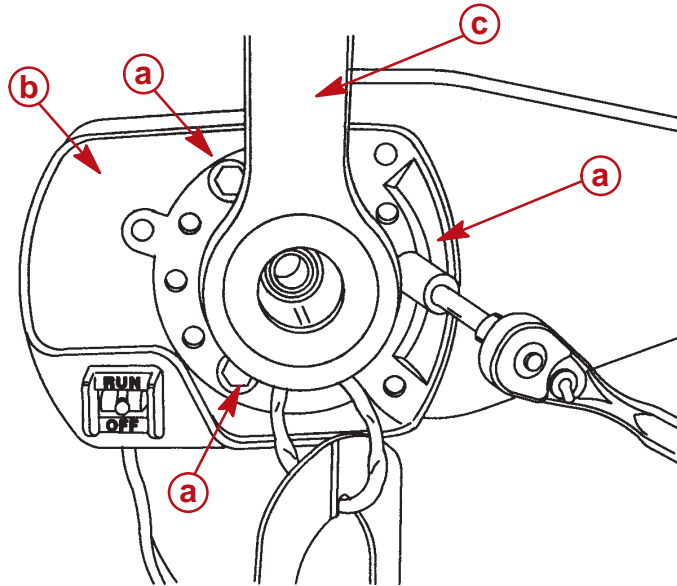
59551

- a** - Mounting Screws (3)
- b** - Bezel
- c** - Remote Control Handle

Loosen the (3) 1/4-20 screws securing the module assembly to the bezel plate just enough to allow for module free movement.

Place the handle hub bushing back into position in the bezel plate opening. Using the handle hub as a centering tool, and with the bezel plate cover out of the way, push the handle hub in firmly towards the module letting the module align itself with the bezel plate. Using a ¼ in. drive 7/16 in. deep well socket and a short extension, begin tightening one or two of the 1/4-20 screws just enough to loosely draw the module up to the bezel plate while rotating the handle back and fourth several times, allowing the module to center itself into position.

Remove the handle assembly and finish tightening the (3) 1/4-20 screws securely. Install the bezel cover plate and handle assembly back into position. Place a small drop of Loctite 271 (only needed if the original locking material seal was broken) onto the brass handle nut threads and tighten to 17 Nm (150 lb-in.). This procedure should help improve the component alignment and reduce or even out the normal handle friction rate. The handle should now rotate in both directions with the same amount of effort. Reconnect the throttle and shift cables at the engine end.

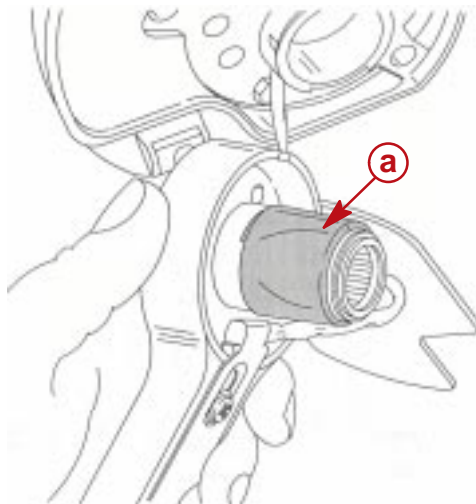
59550

a - Duct Tape

Wrapping a temporary piece of duct tape around the handle hub two times will help center the module to the bezel opening even quicker and may not require rotation of the handle. If used, don't forget to remove the tape before securing the handle to the module for the final assembly.
