MerCruiser Service Bulletin

MCM Shift Plate Cable Attaching Hardware

Models Affected Gas and Diesel

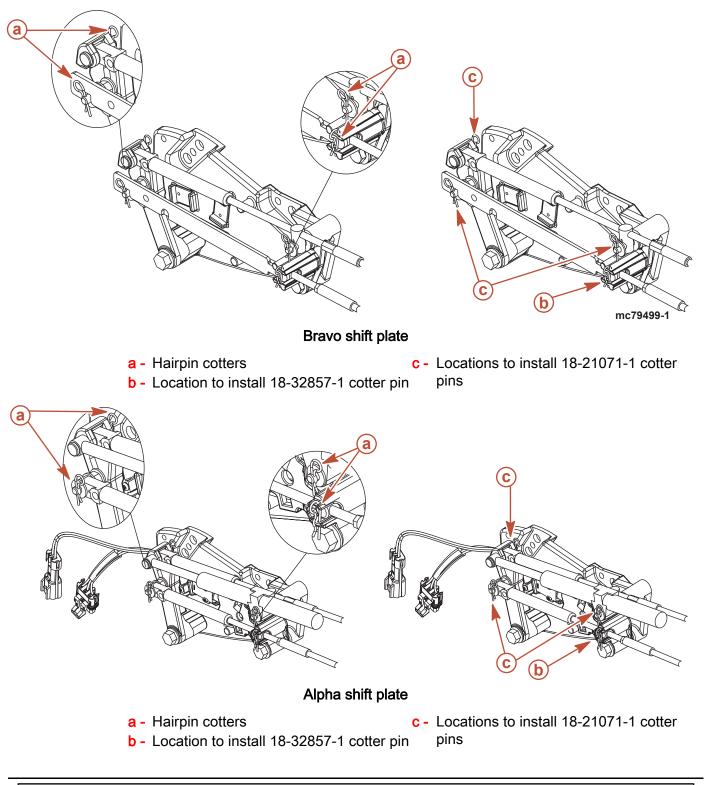
All affected MCM engines have a new shift plate assembly installed. These assemblies have a hairpin cotter for the shift cable attaching hardware that may come loose and fall out. The hairpin cotters that retain the shift cables to the studs and shift lever clevis pin on the shift plate assembly on all affected MCM engines may be bent open and will come loose and fall out. If that occurs, the shift cable will become disconnected from the shift plate, which will cause a loss of shift control.

Remove hairpin cotters (a) 18-859746 from all anchor points on the shift plate, and replace with (1) of 18-32857-1 cotter pin at the shift cable anchor on the Alpha switch actuating arm and Bravo shift cable retainer plus (3) of 18-21071-1 on the two studs and the clevis pin on the shift lever.
