# Service Bulletin

Bulletin No. 2007-66R1  
CMD 2007-06R1

## Official Recall Notification U.S. Federal Boat Safety Act—QSD 4.2 ECM Bolt Interference with Fuel Line

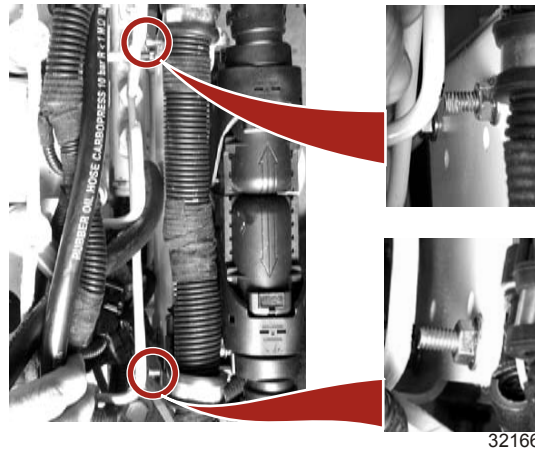
#### Locations of possible interference

3. Inspect for interference with the top two vibration damper studs and the high pressure fuel lines for cylinders number 1 and 3 . Replace fuel lines that are damaged. Refer to the appropriate CMD engine service manual.
4. Cut the plastic cable ties anchoring the ECM harnesses to the ECM mounting bracket (if equipped).
5. Disconnect the two harness connectors from the ECM.

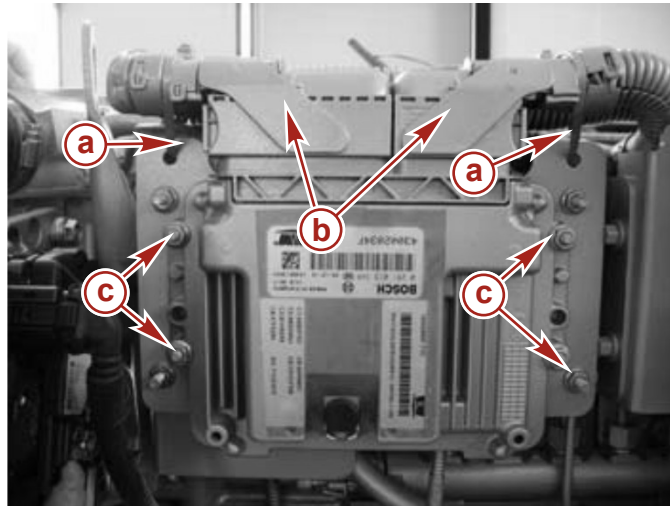
32147

- a** - Cable ties
- b** - ECM harness connectors
- c** - Flange nuts

6. Remove the four flange nuts connecting the ECM plate to the vibration dampers.

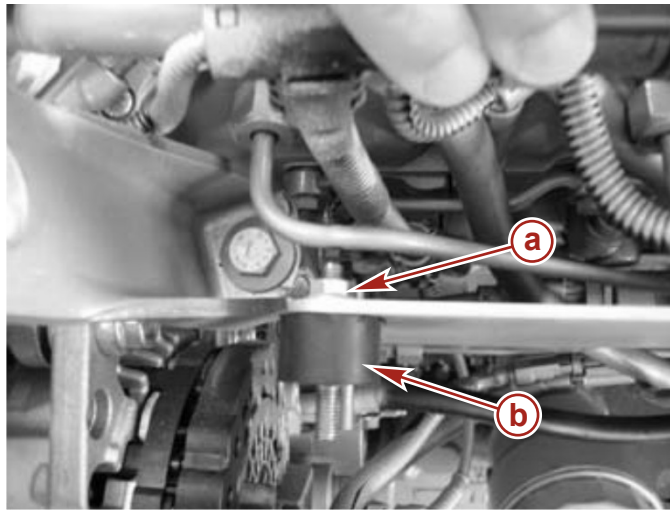
32145

- a** - Flange nut
- b** - Vibration damper

7. Remove all four vibration dampers by loosening the flange nut on the rear of the ECM mounting bracket.

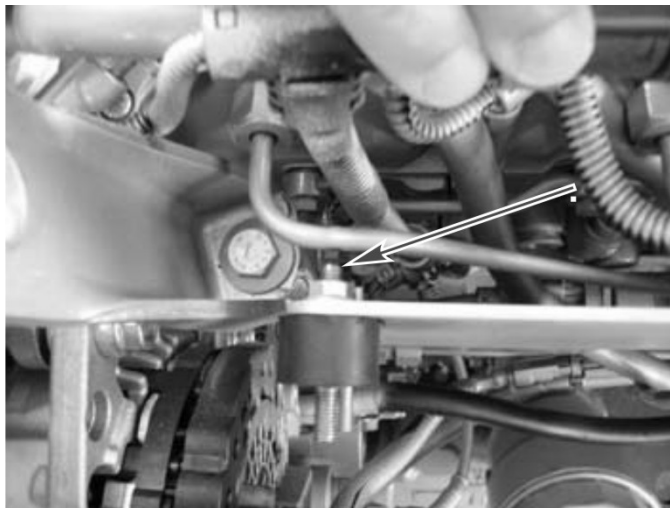
32155

**Vibration damper with short stud toward engine**

8. Install the four new vibration dampers with the shorter stud toward the engine.

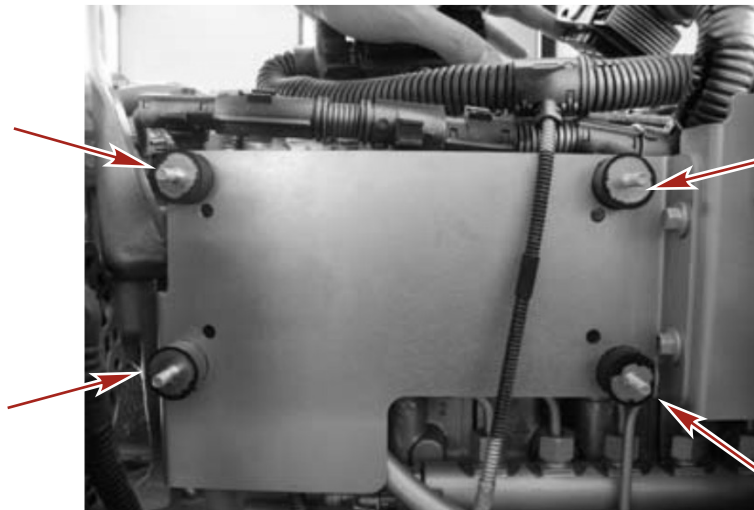
32146

**Vibration damper ECM mounting studs**

9. Torque the four flange nuts attaching the vibration dampers to the ECM mounting bracket to specification.

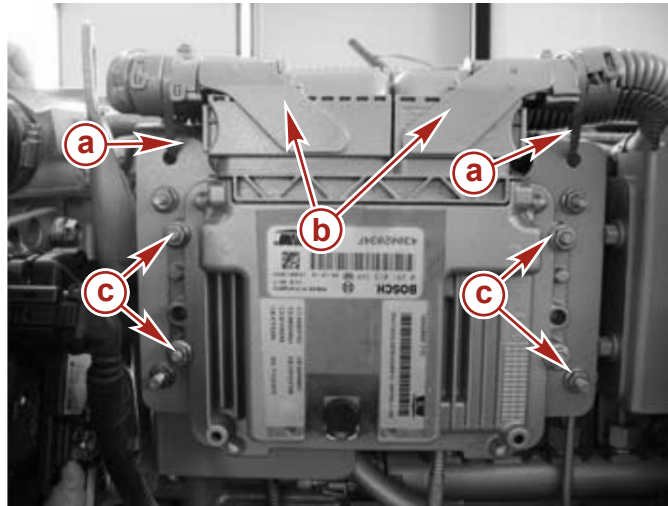
32147

- a - Cable ties
- b - ECM harness connectors
- c - Flange nuts

13. Secure the ECM wiring with new cable ties.
