Service Bulletin

Bulletin No. 2007-64
CMD 2007-04

QSD 2.0 Turbocharger Oil Supply Pipe

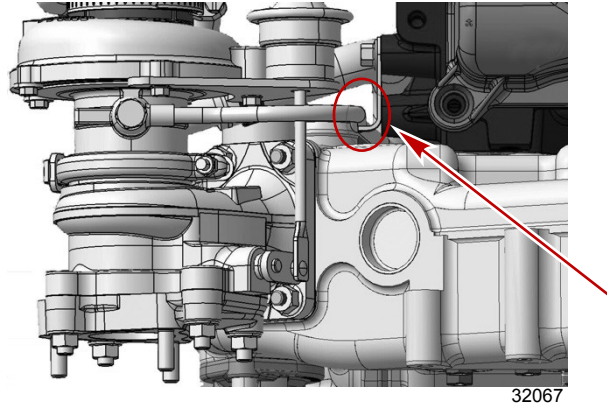
Early production QSD 2.0 engines may have been shipped with a turbocharger oil supply pipe that has an attachment bracket welded to the pipe. The welded joint may crack causing the pipe to leak. The oil supply pipe has been redesigned to use a bracket that wraps around the pipe.

Welded turbocharger oil supply pipe bracket—incorrect

Inspect all engines within the serial number range. Replace the turbocharger oil supply pipe on all engines that have the welded attachment bracket. Refer to **Identification**.

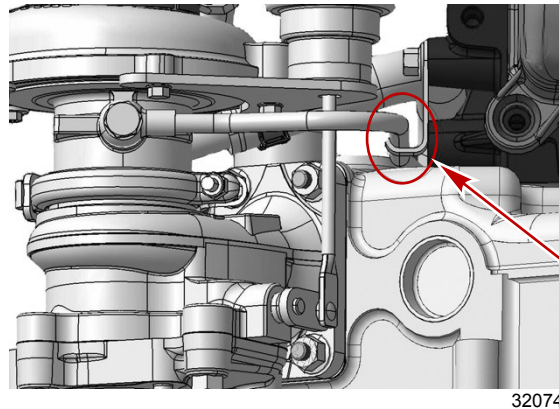
Wrapped Turbocharger oil supply pipe bracket—correct
