Bulletin No. 2007-63

QSD 2.0 Sterndrive Power Steering Cooler Interference Models Affected

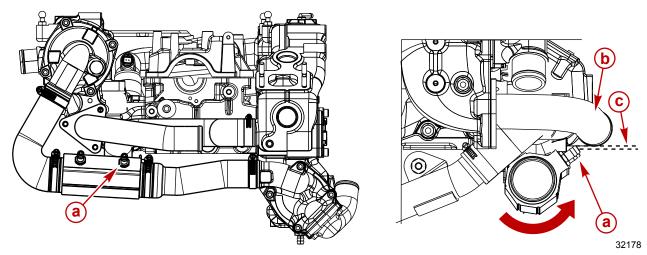
- a Fitting
- **b** Air crossover tube
- c Clearance
- 7. Check for interference between the back of the power steering cooler and the engine coolant hose. Adjust if necessary.

6. Rotate the power steering cooler until there is clearance between the referenced fitting and the under side of the air crossover tube.
