Diagnostic Supplement for MerCruiser Engines with Emission Control Technology (ECT)

NOTICE
Revised January 2014. This bulletin supersedes the previous bulletin number 2011-11R1 November 2011.

Models Covered
All sterndrive and inboard engines with emissions control technology (ECT)

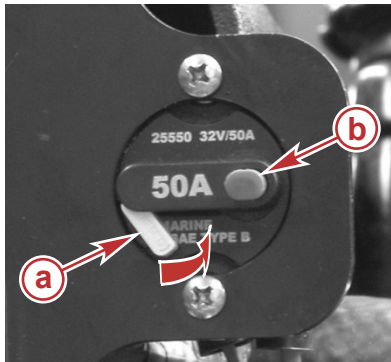
54122

1. Some engines, dating back to 2002, were manufactured with the yellow-flag type circuit breaker, which has been associated with misfires between 2000 and 4000 RPM, the engine is at its peak load, as when working to get the boat up on plane. Refer to **Misfires Due to Yellow-Flag-Type 50-Amp Circuit Breaker** later in the document for information on diagnosing and repairing this issue.
2. 5.0L, 5.7L, and 6.2L EC engines with low hours, no other faults, and misfiring occurring when the engine is put under high load, such as when coming on plane. Refer to **5.0L, 5.7L, and 6.2L ECT Engines Misfire with Low Engine Hours and No Other Active Faults** later in this document for more information on diagnosing and addressing this issue.

Since 2002, some engines were manufactured with a yellow-flag-type circuit breaker. The 50-amp circuit breaker is the main voltage supply (through the main power relay) for the engine fuse block, which supplies voltage to the fuel injectors, coil and coil driver, PCM drivers, all 5-volt and 12-volt sensors, and O2 sensor heaters.

Yellow flag type 50-amp circuit breaker

If temporarily bypassing the circuit breaker resolves the fault, replace the circuit breaker with a push-button type.

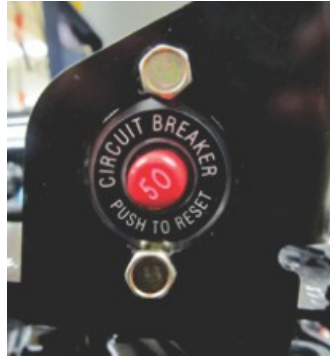
NOTE: The flag-type circuit breakers have been superseded by the push-button type.

New type 50-amp circuit breaker

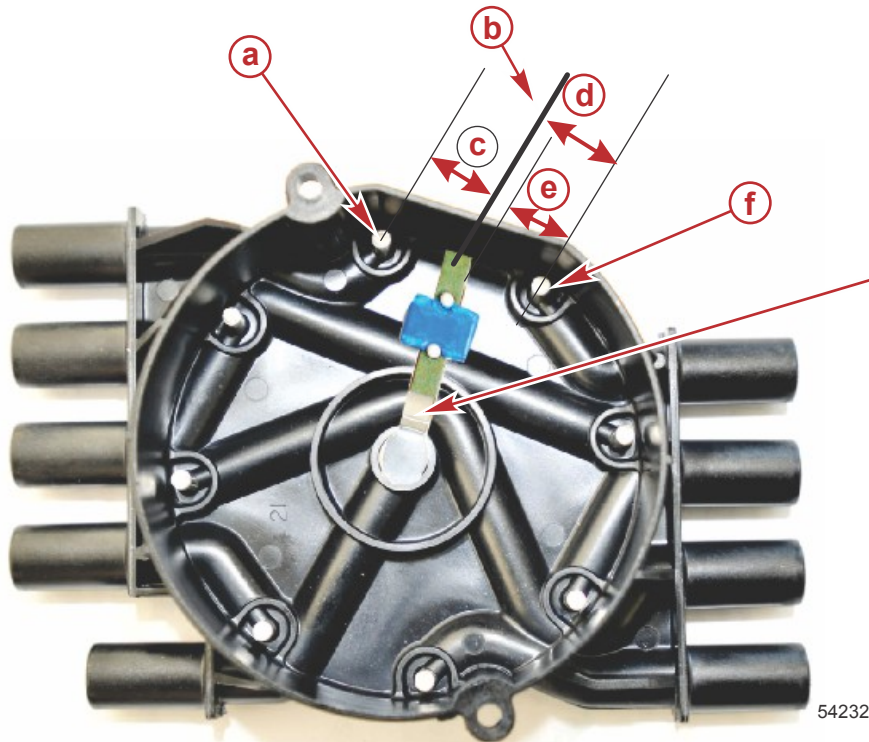
After 30–100 engine hours, the tolerance between the distributor (high-voltage switch) and the drive components may increase. As the timing chain, timing gears, distributor shaft drive gear and cam gear all wear in, the rotor shaft may become slightly out of phase with the distributor housing, which can result in misfire under load.

Distributor/HVS rotor positions before adjustment

- a** - Tower for cylinder just fired
- b** - Midpoint between two cylinder towers. Also the position of the rotor at maximum spark advance.
- c** - Space between rotor and cylinder just fired at maximum spark advance
- d** - Space between rotor and cylinder fired at 30° before TDC (maximum spark advance)
- e** - Approximately 24° before TDC
- f** - Tower of cylinder to be fired
- g** - Rotor
