Field Campaign on 8.2 Inboard ECT Engines

Inboard Models	Serial Number
8.2 Horizon DTS ECT	1A350802-1A353889
8.2 H.O. DTS ECT

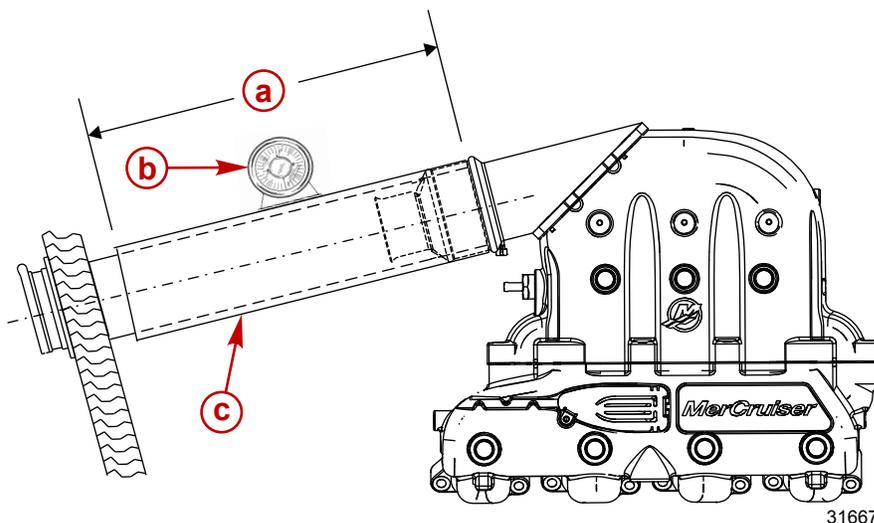
NOTE: Measure the marine grade exhaust tubing aft of the elbow to ensure the minimum distance of 457 mm (18 in.). If this dimension is below the specification contact your boatbuilder.

- a - Minimum 457 mm (18 in.)
- b - Inclinometer
- c - Exhaust hose or tube

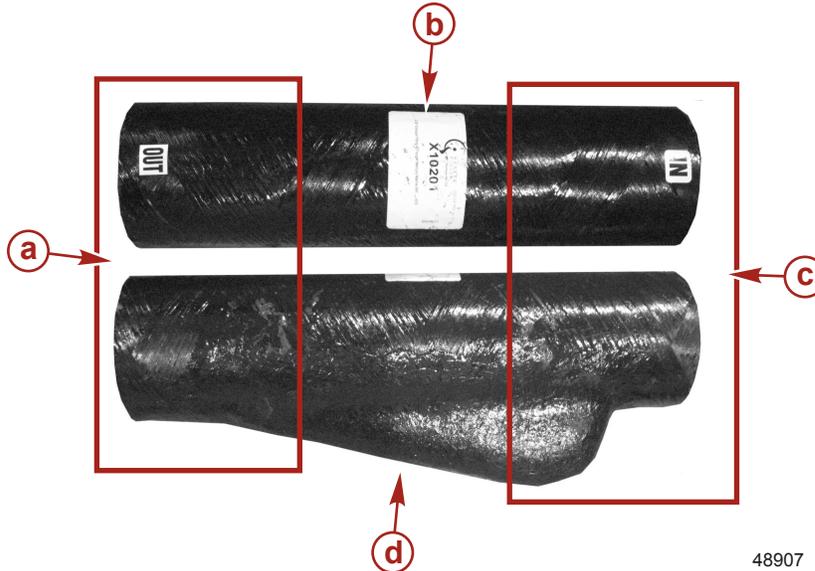
IMPORTANT: To function properly, the end of the tube marked "IN" is positioned toward the engine exhaust elbow with the deepest portion of the diverter tube facing straight down. Do not cut or modify the diverter tube.

- a - End of diverter tube marked "OUT"
- b - Top view of diverter tube
- c - End of diverter tube marked "IN"
- d - Side view of diverter tube

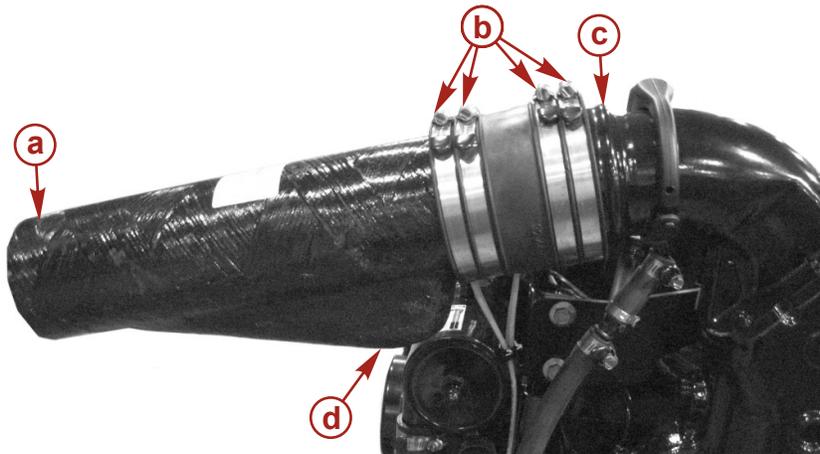
Side view

- a - End of diverter tube marked "OUT"
- b - Hose clamp (4)
- c - Ridge
- d - Correct straight down position of deepest portion

- Install the exhaust tube and diverter tube assembly on the exhaust elbow on the engine. Position the deepest portion of the tube facing straight down.
- Ensure that the screw head on the hose clamps are facing toward the outside of the engine and the exhaust tube is against the ridge on the exhaust elbow.
- Tighten the hose clamps to specification.

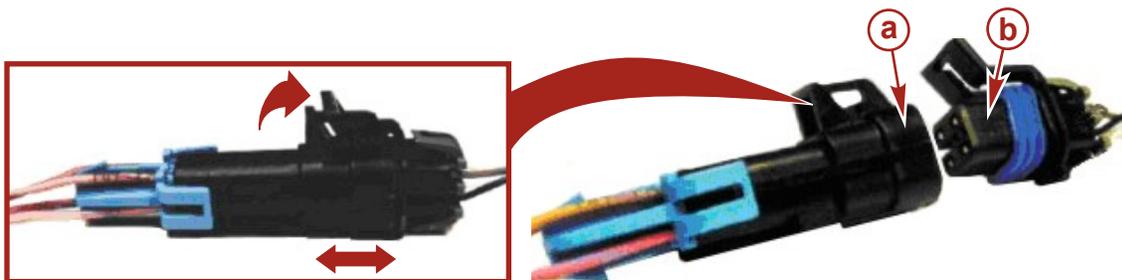
Pre-exhaust and post-exhaust oxygen sensor

NOTE: Inspect O2 sensor wiring connections for any signs of black paint, if found replace O2 sensor.

- a - Engine harness connector (male)
- b - Oxygen sensor connector (female)
