# Service Bulletin

Bulletin No. 2012-05 OEM No. 2012-04

## Official Recall Notification U.S. Federal Boat Safety Act – Fuel Line Balance Hose For All 8.2 Models

Models Covered	Serial Number Or Year
All 8.2 ECT and Non ECT Models	1A350340–2A030176

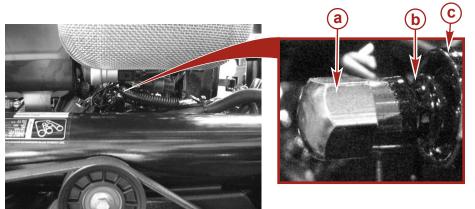
48724

- a Cap
- **b** Schrader valve
- c Fuel rail

1. Install the fuel pressure gauge at the Schrader valve located on the front of the fuel rail and relieve pressure in the fuel rail by draining the fuel into a container which can be poured back into the tank or disposed of properly.
