SmartCraft Clean Power Harness

Models Affected

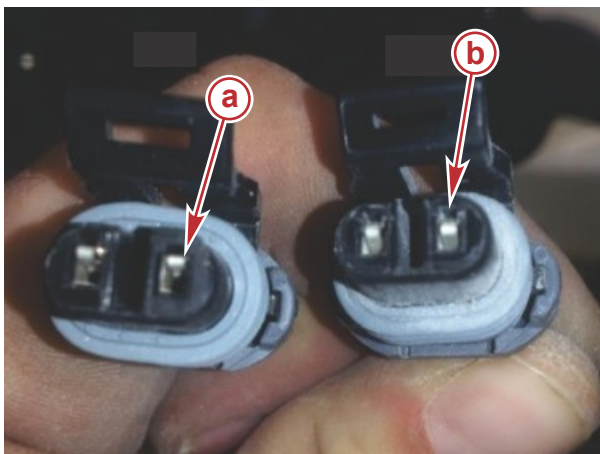
53621

During the manufacturing process some of the female terminals in the clean power 2-pin connector were spread too wide, creating the possibility for either an intermittent electrical failure (occasional engine shutdown), or a complete break in power (engine cannot start, or started then stopped and cannot be restarted). For connectors that were not spread too wide during the manufacturing process, normal electrical component performance and reliability is expected. For connectors that were spread too wide there is a high probability that one of the two electrical failures (intermittent or complete open circuit) will occur either immediately on attempted engine start-up, or very soon thereafter.

a - Bad
b - Good

Correct if any of the conditions described in the **Situation** section are reported by the customer, or observed during setup, inspect the battery connections and replace any clean power harness in the date codes listed if the conditions mentioned in this bulletin are present. Replace with P/N 888416T04.

NOTE: Do not attempt to repair the harness. Replace clean power harness complete.

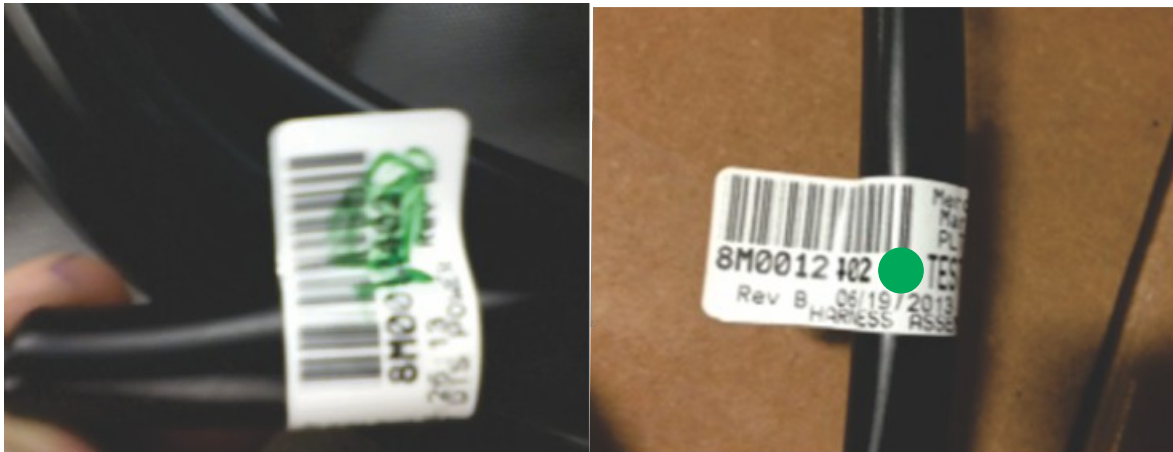
53622

Parts inspected at the factory will have a green mark on the P/N tag.

Dealer identification
