Official Recall Notification U.S. Federal Boat Safety Act - Possible Incorrect Routing of Engine Wire Harness on 5.0L, 350 Mag, and 6.2L

Models Covered	Serial Number Or Year
5.0L, 350 Mag, and 6.2L Non-EC DTS sterndrive engines	2A014073–2A050912

Contact your Mercury MerCruiser dealer and make arrangements for the inspection and possible repair. There will be no cost to you for the inspection or repair. If you have questions or no longer own this boat, contact Mercury MerCruiser Customer Service at +1 920-929-5040. The dealer will refer to Mercury MerCruiser Service Bulletin 2013-03 for instructions on inspecting and replacing the engine wiring harness.

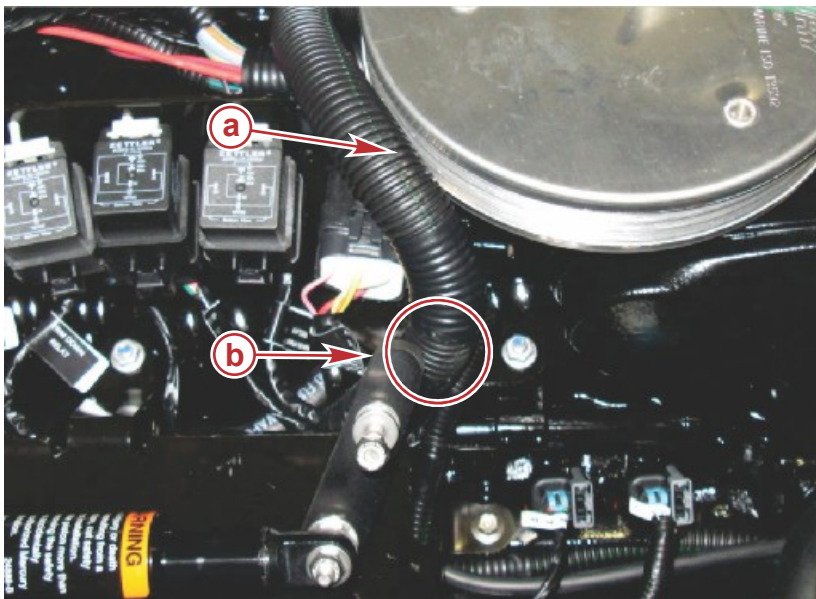
52546

Example of incorrect routing

- a - Wire harness routed along the side of the flame arrester
- b - Wire harness not secured to electrical plate, possibly contacting the shift arm

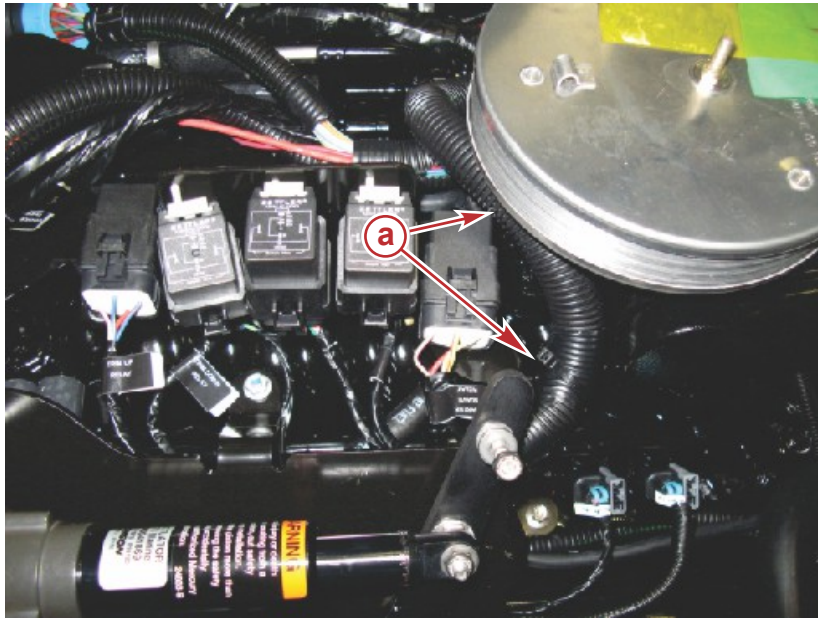
52548

Example of a correctly routed harness

- a** - Correctly routed under flame arrestor and secured to foot of electrical plate

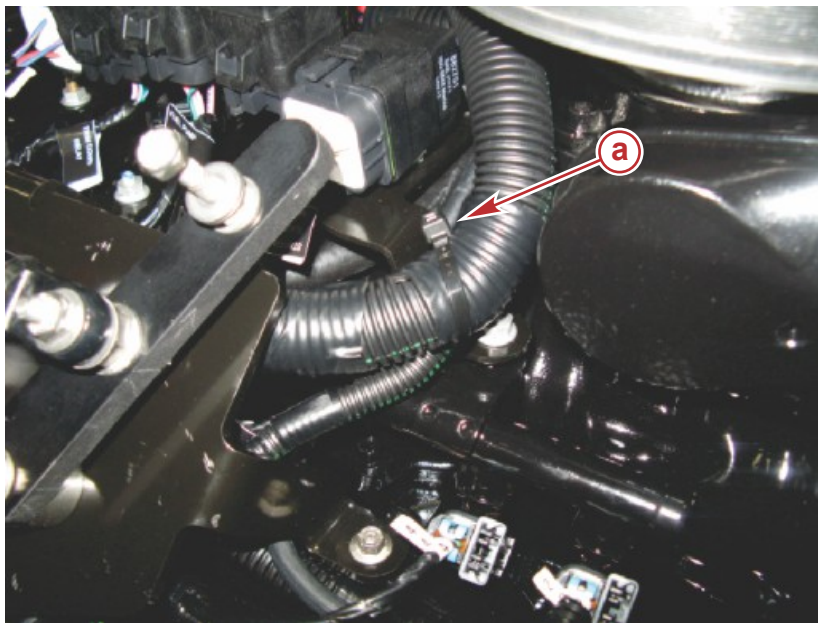
52549

Example of the cable tie installed correctly

- a** - Secured with cable tie to the foot of the electrical bracket

- a. Verify that the cable tie is installed around the base of the electrical bracket, securing the harness and preventing it from contacting the shift actuator arm.

- b. If the cable tie is not installed, install the cable tie around the harness, securing it to the foot of the electrical plate.
- 4. If the wire harness is routed incorrectly, carefully inspect the harness for damage in the area where the shift actuator arm contacts the harness.
 - a. If damage is present, proceed to step 5
 - b. If no damage is present, proceed to step 7.
- 5. If the harness is chafed or scuffed but the insulation appears intact:
 - a. Securely tape the chafed area with at least two layers of electrical tape.
 - b. Route the wire harness to match the routing of the harness in step 7.

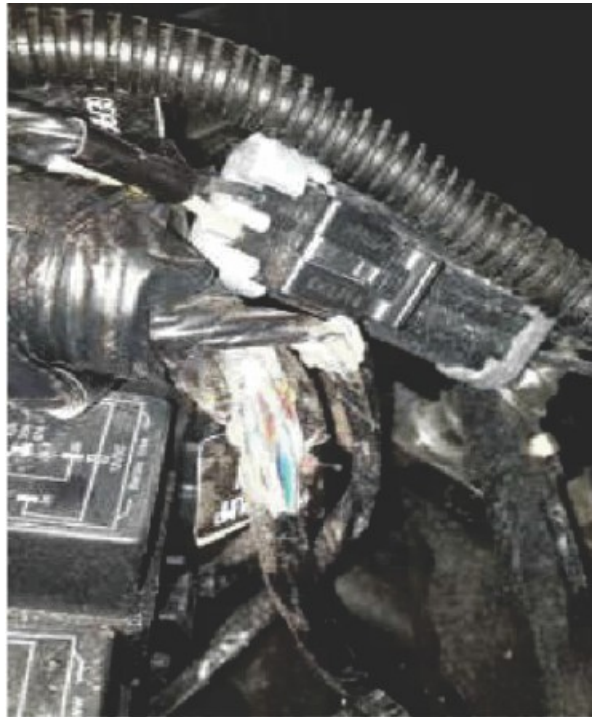
52550

Example of damaged insulation and bare wire

- a. Replace the complete wire harness. Order the part number listed in the Replacement Parts section.
 - b. Route the replacement wire harness to match the routing of the harness in step 7.
7. Correct routing of the harness:
- a. Remove engine flame arrestor
 - b. Secure the harness to the foot of the electrical plate bracket with a cable tie matching the second image in step 3.
