Zeus Guardian Strategy and Updates for SC2.5

Notice
Revised April 2017. This bulletin supersedes the previous bulletins, numbers 2013-66 and 2013-66R1 dated June 2013 and December 2014.

Models Covered	Year
Zeus KH Pods	2012-2016

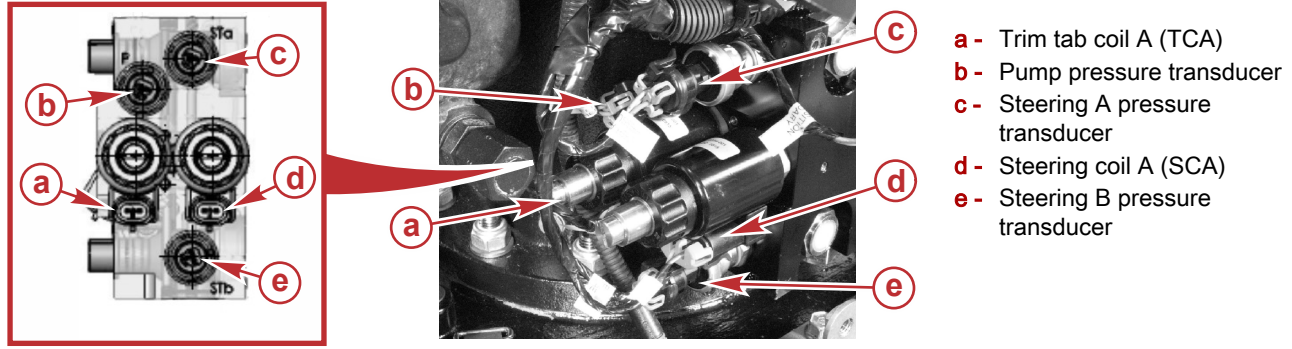
41885

IMPORTANT: To determine if the hydraulic pressure transducers must be replaced, select the eBOM screen in CDS G3. If the uppermost eBOM, the one with the most matches is "Pod Drive - Zeus SC2.5 V0," replace the transducers. A physical inspection of the label on the transducers can also show you if replacement is necessary. Transducers labeled as 3000 psi must be replaced.

The hydraulic steering manifold for each pod contains three pressure transducers. These steering pressure transducers are identified by letters b, c, and e in the following illustration.

There are a total of five transducers on the steering and trim tab hydraulic systems of each pod. Replace each of the five transducers on each pod.

Tighten each transducer to the specified torque.

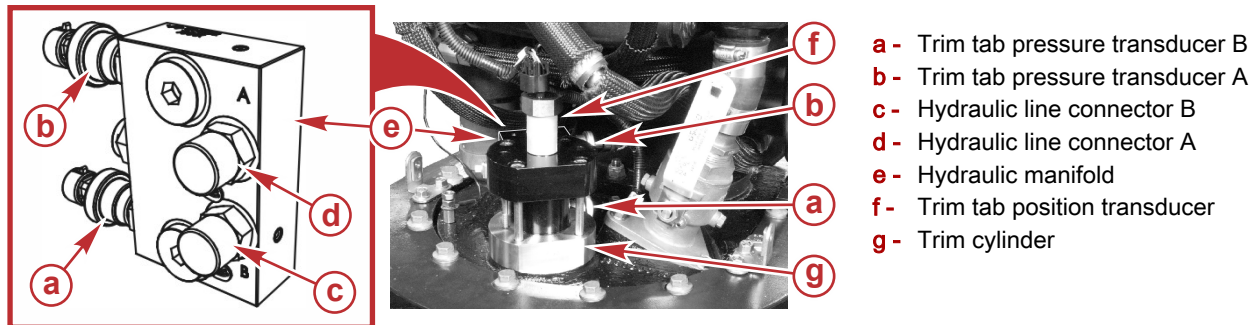
42111

The hydraulic trim tab manifold for each pod contains two pressure transducers. These trim tab pressure transducers are identified by letters a and b in the following illustration.
