## MerCruiser Generation III Cool Fuel Module

Revised September 2017. This bulletin supersedes the previous bulletin number 2014-07R1 January 2015.

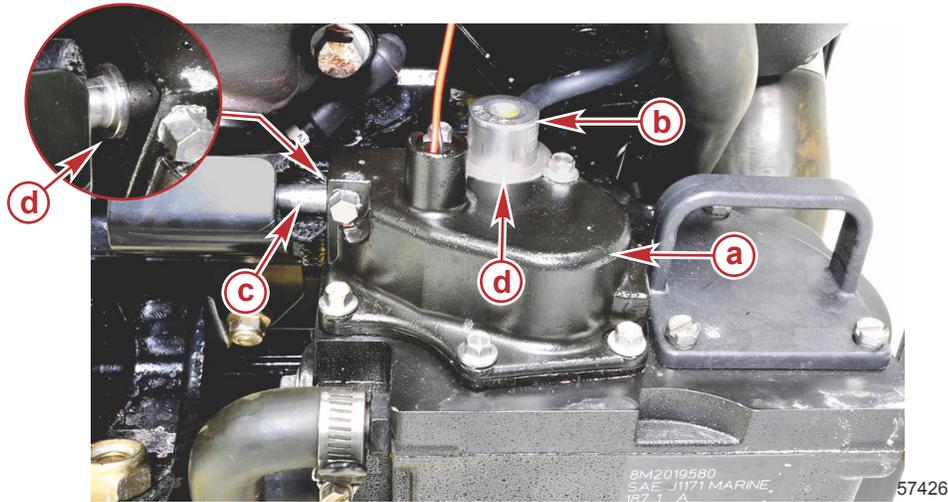
### Cool Fuel module

A situation has been identified whereby fuel may weep or very slowly leak from either the area under the fuel pressure regulator or at the joint between the Gen III Cool Fuel module and the discharge fuel line that carries fuel to the fuel rail, in the products listed above.

If you encounter the above condition, thoroughly inspect the areas around the fuel pressure regulator, discharge fuel line, and below the Gen III Cool Fuel module for the accumulation of fuel residue.

- a** - Cool Fuel module top cover
- b** - Fuel pressure regulator
- c** - Discharge fuel line
- d** - Inspection points

If signs of fuel weepage are observed at the inspection points, replace the Gen III Cool Fuel module top cover and seal, fuel pressure regulator, and the discharge fuel line quad ring. These components are available as a kit; order part number 8M0130861.
