## Zeus Guardian Strategy and Audio Warning Updates

| Revised August 2018. This bulletin supersedes the previous bulletin number 2017-61R2, October 2017. |

| Models Covered | Year |
|--|---|
| Zeus LH and KH Pods in Vessels with Design 1 Joysticks | 2015–2017 |

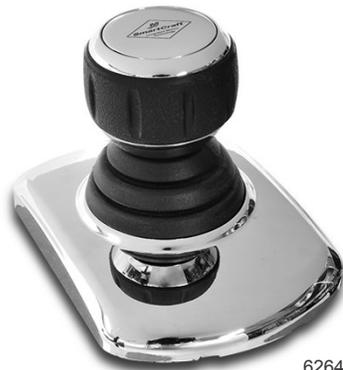
62641

**Design 1 joystick**

Vessels equipped with Zeus propulsion systems in the affected model range require a software reflash that includes a new engine Guardian strategy. The updated software will generate an alarm and reduce power when the exhaust temperature threshold is exceeded. A critical exhaust temperature overheat will shutdown the engine.

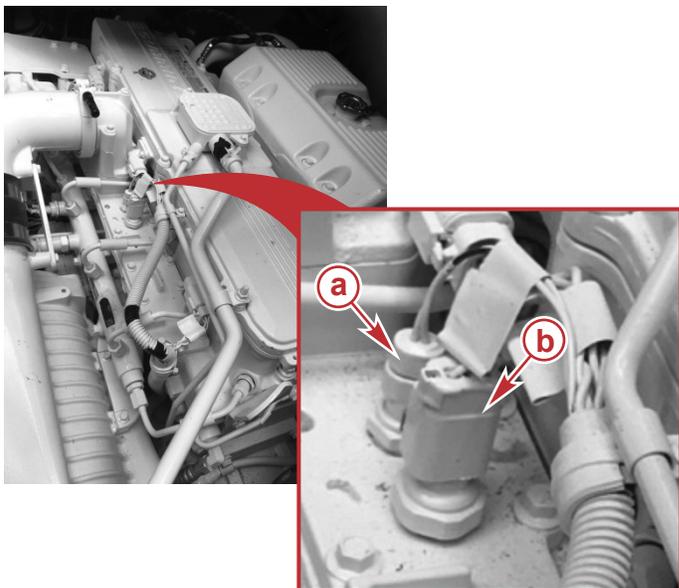
63021

- a - Intake manifold temperature sensor
- b - Boost pressure sensor

- a. Disconnect the intake manifold temperature sensor.

- b. Ensure that a fault has occurred by viewing the VesselView screen for the fault indication. Alternatively you can observe CDS G3 in the module data screen. A module that is faulting will indicate so in the right hand column of CDS G3's module data. Ensure the Intake Manifold Temperature fault you are triggering shows up in the starboard or port SIM.

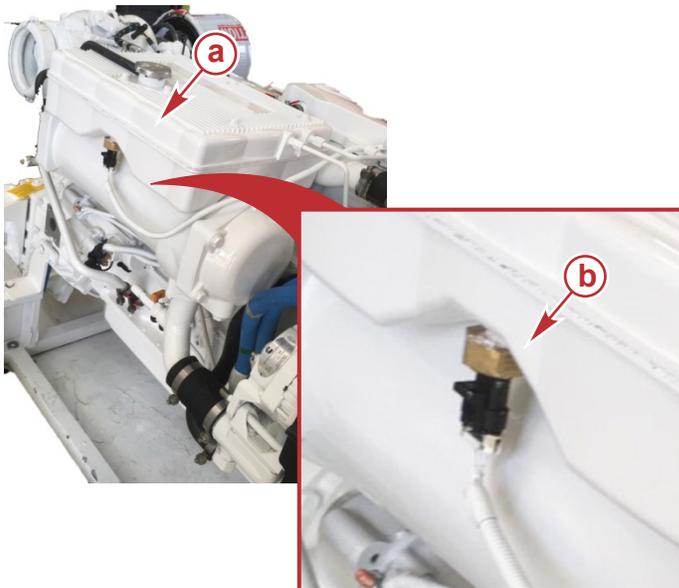
63026

- a - Reservoir
- b - Coolant level sensor

- a. Disconnect the coolant level sensor.

- b. Ensure that a fault has occurred by viewing the VesselView screen for the fault indication. Alternatively you can observe CDS G3 in the module data screen. A module that is faulting will indicate so in the right hand column of CDS G3's module data. Ensure the Coolant Level Sensor fault you are triggering shows up in the starboard or port SIM.
- 3. The audio warning system should sound for six one-second intervals.
- 4. Turn the keys off and pull the electronic remote control handles back to reverse wide open.
- 5. Turn the keys on again and verify the presence of the faults and the audible caution horn—6 beeps.
