service bulletin

No. 92-2

Official Notification - Federal Boat Safety Act Flywheel - 1991 & 1992 150 HP Models

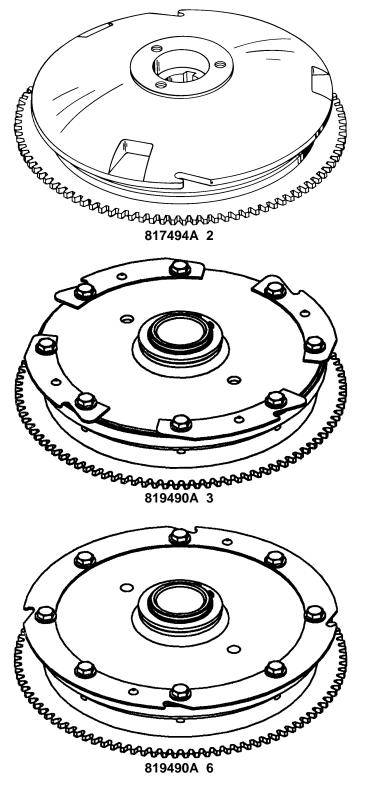
During the assembly process of the 819490A 3 flywheel, some fasteners which retain the emergency starter plates and hub plate to the outer rim of the flywheel were insufficiently torqued. This condition could lead to the fatiguing of these fasteners and ultimate flywheel failure. Such a failure would result in one of the emergency starter plates releasing from the flywheel. The engine cowl will provide protection from possible injury should this occur.

To summarize, there are three flywheels involved in the two campaigns. Each one is distinctly different. See figures below.

The 817494A 2 flywheel is the solid hub design. This flywheel was being replaced by the 819490A 3 flywheel per Service Bulletin #SB 91-11.

The 819490A 3 flywheel is the original rubber cushioned hub flywheel. This design eliminated an engine harmonic vibration between 4150 and 4400 RPM's, as described in #SB 91-11.

The 819490A 6 flywheel is the improved version of the 819490A 3 flywheel. This flywheel has larger fasteners and other changes.

We will be conducting a field campaign to replace all flywheels for the models listed in this bulletin. Engineering has re-evaluated the flywheel design. Improvements have been incorporated to make the flywheel easier to assemble and more reliable. The part number for the new flywheel is 819490A 6. This is the replacement flywheel which will be used in this campaign.
