## Propeller Shaft Seal – 40, 50, and 75 HP

### Models Affected

1998 Force 40, 50, and 75 HP

Serial Number – 0E311411 thru 0E313993

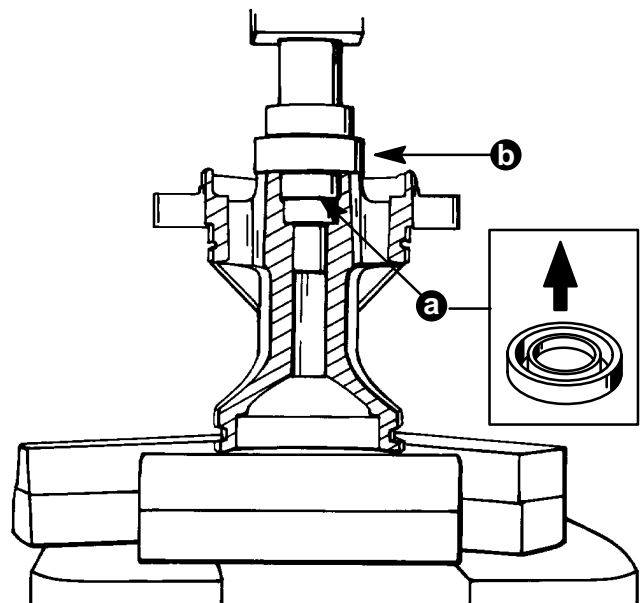
The outer propeller shaft seal in the bearing carrier on the models listed may cause water to enter the gear housing. Replacement of the seal is required for outboards within the serial numbers listed that have not been reworked at the factory. The seal that requires replacement has a carbon steel compression spring and is replaced with a seal using a stainless steel spring. Outboards reworked at the factory have a green dot on the upper rear of the gear housing above the anti-ventilation plate and a green dot on the outside of the shipping carton next to the serial number for identification.

a - Outer Seal

b - Mandrel 91-817007

Replace the outer propeller shaft seal on outboards within the serial numbers listed that have not been reworked at the factory. It will be necessary to remove the bearing carrier from the gear housing. Remove and replace only the outer propeller shaft seal. The outer seal is installed with the seal lips facing out. Apply grease between the two seals for extra durability. Refer to the service manual for proper seal installation instructions. Paint the end of the propeller shaft white to identify the installation of the new seal.

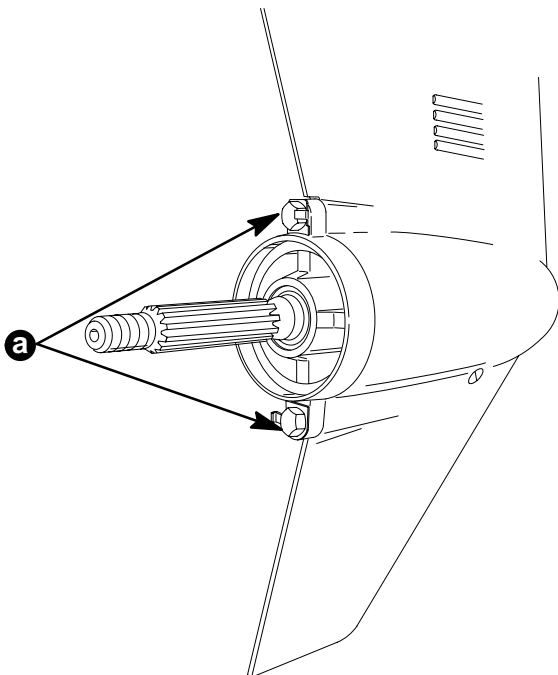
a - Torque Bolts to 225 lb. In./ 18.8 lb. Ft. (25.4 N·m).

**Bearing Carrier Installation:** This new service information applies to all the models listed in this service bulletin. Installation of the bearing carrier requires replacement of the original washers and bolts. This change allows for an increase in the bearing carrier bolt torque. Discard any locking tab washers or the previous 0.063 in. (1.60 mm) thick flat washers and the previous 25 mm long bolts. They should be replaced with new 0.090 in. (2.29 mm) thick flat washers p/n 12-855941 and longer 30 mm bolts p/n 10-855940-30. The bolts should be torqued to a higher specification of 225 lb. In./18.7 lb. Ft. (25.4 N·m). The service manuals will have the new procedures and revised torque specification included in the next revision.
