Gearcase Failures – 90/120 HP

Models Affected

1995, 1996 and 1997 Force 90/120 HP Models, serial number

0E093700 thru 0E287999

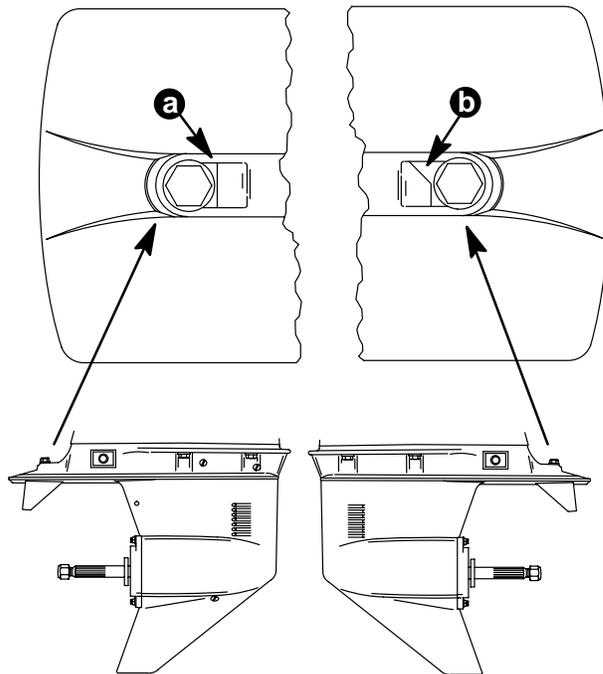
1987 – 1997 "3 Jaw Reverse Clutch" 1998 and Newer "6 Jaw Reverse Clutch"

Identify gear case design to ensure correct components are being installed. Design I - "3 Jaw Reverse Clutch" (a) gear case identified with straight machined edge for trim tab screw mounting surface. Design II - "6 Jaw Reverse Clutch" (b) gear case identified with angled machined edge for trim tab screw mounting surface.

- a - Design I - "3 Jaw Reverse Clutch" Gear Case Identifier
- b - Design II - "6 Jaw Reverse Clutch" Gear Case Identifier

After the "6-Jaw Reverse Clutch" gearcase and updated Shift Shaft have been installed replacement parts **MUST** be ordered from the 1998 model year parts list. "3-Jaw" and "6-Jaw" reverse clutch parts are **NOT** interchangeable.
