Bulletin No. 2002-12

## New Design - Lower Bow Arm Pin

All 01 and 07 Bow Mounts

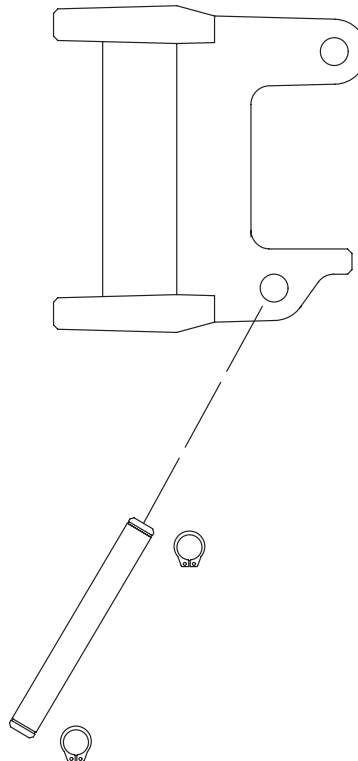
00143

The lower bow arm pin that connects the bow arm to the bracket door assembly on all 01 and 07 bow mounts has been modified in order to ease assembly of the parts. The newly designed lower pin is similar, but not identical, to the upper pin. Both the pin and the retainer ring of the previous design, part numbers MBK04604 and 17-MBK10205, are No Longer Available (NLA).

**IMPORTANT: The old parts cannot be superseded to the new part numbers because the old and new parts must not be intermixed.**
