service bulletin

☐ WARRANTY INFORMATION☐ PARTS INFORMATION	SERVICE INFORMATION		DN Bul	Bulletin No. 2003-04	
Circulate to: Sales Manager A	ccountina	Service Manager	Technician	Parts Manager

Incorrect Door Knob Bushing On 21/24 Gator Mounts

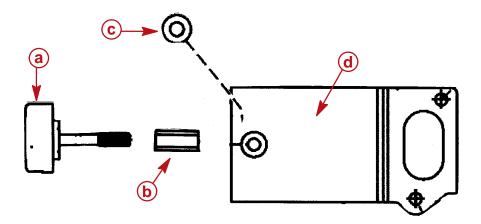
Manufacturing may have installed a plastic door knob bushing on the above listed mounts rather than the normal metal bushing.

If the plastic door knob bushing is found in the above listed mounts, replace the bushing with a metal door knob bushing.
