Official Recall Notification U.S. Federal Boat Safety Act: Improper Overcurrent Protection on Starter Solenoid and Alternator Sense Circuit

Models Affected

Models Covered	Serial Number Range
HP525 EFI	0M900146 through 0M962496
HP600 Sci, HP662 Sci, HP700 Sci	
HP850 Sci, HP1075 Sci, HP1200 Sci

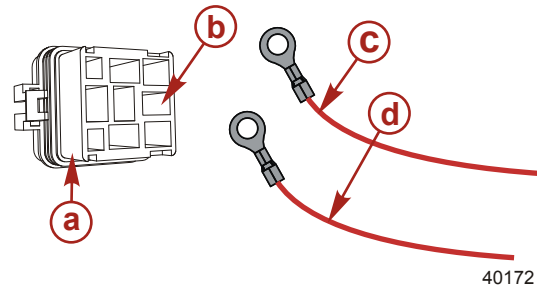
a - Main power relay connector
b - Position 1

c - To existing 50 amp circuit breaker
d - To main power relays

IMPORTANT: Use an ohmmeter to locate the proper wire to connect the 50 amp fuse to on engines equipped with a 10-Pin harness connecting the engine harness to the helm.

7. With the wires disconnected from the 90 amp fuse, find the wire that feeds the Main power relays. Connect an ohmmeter from the ring terminal to the #1 position on the Main Power relay connector. Use that wire in the next step.
8. Connect the smaller connector of the 50 Amp fuse assembly to the 8 gage wire that feeds the main power relays with the nut and bolt. Slide the heat shrink sleeve over the connectors and apply heat to the sleeve to seal the connection.

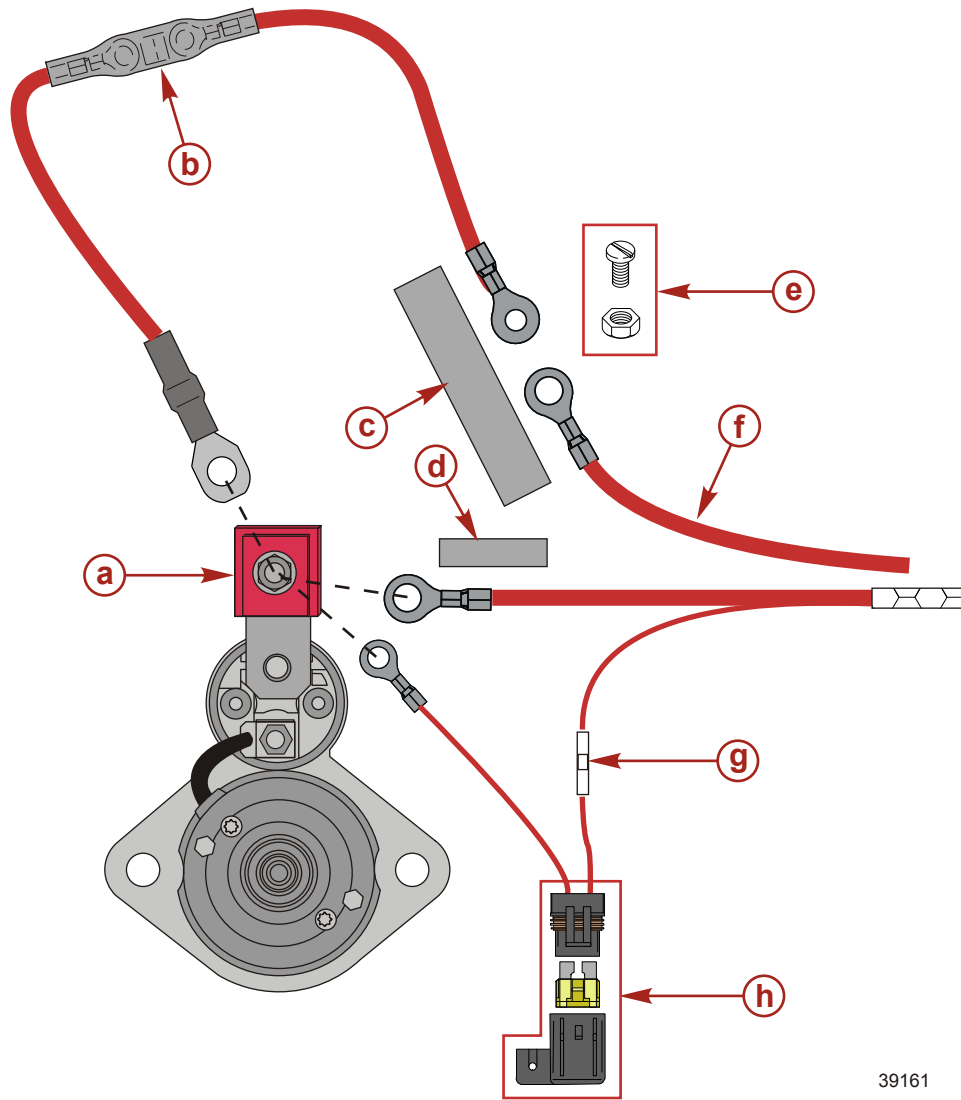
- a - 90 Amp fuse
- b - 50 Amp fuse assembly
- c - Heat shrink sleeve
- d - Heat shrink sleeve

- e - Nut and bolt
- f - To main power relays
- g - Alternator sense wire
- h - 5 Amp fuse assembly

9. Slide the heat shrink sleeve over the remaining 8 gage wire connector and apply heat to the sleeve to seal the crimped portion of the connector.
10. Attach the larger connector of the 50 Amp fuse assembly, the remaining 8 gage wire, and the remaining 5 Amp fuse connector to the 90 Amp fuse with the nut previously removed.

11. Secure the two fuse assemblies to the engine harness with the supplied tie wrap.
