Official Recall Notification Under the U.S. Federal Boat Safety Act

Replacement of Intermediate Shift Cables on Mercury Racing Bravo Stern drives

Replacement of Intermediate Shift Cables on Mercury Racing Bravo Sterndrives

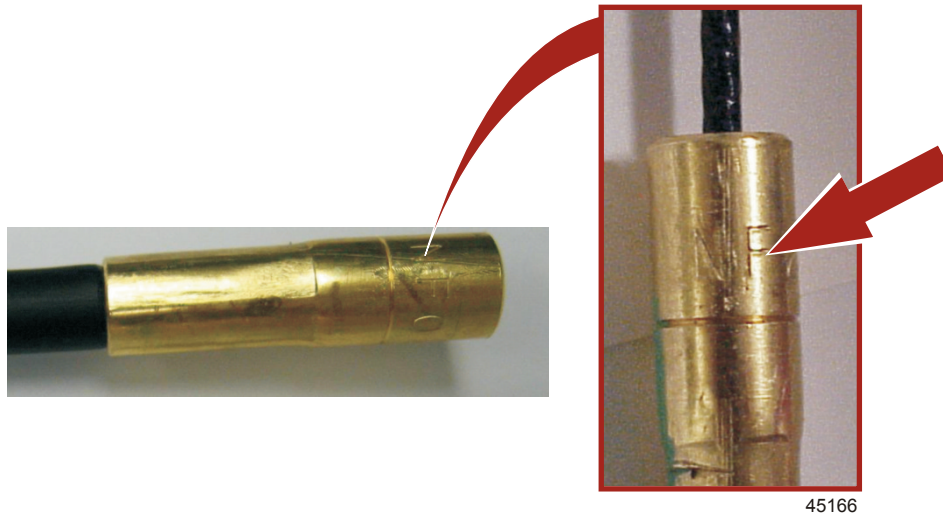
To determine whether a replacement shift cable is affected by this recall, find the cable date code stamped on the barrel of the cable jacket on the shift-bracket end of the cable.

Date code stamp

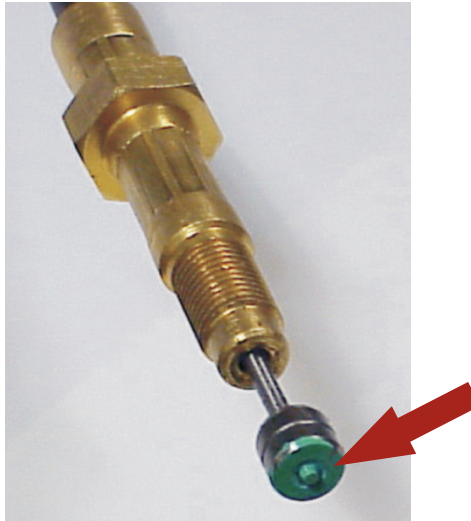
45159

Green or blue dot on the end of the core wire indicates a corrected core wire

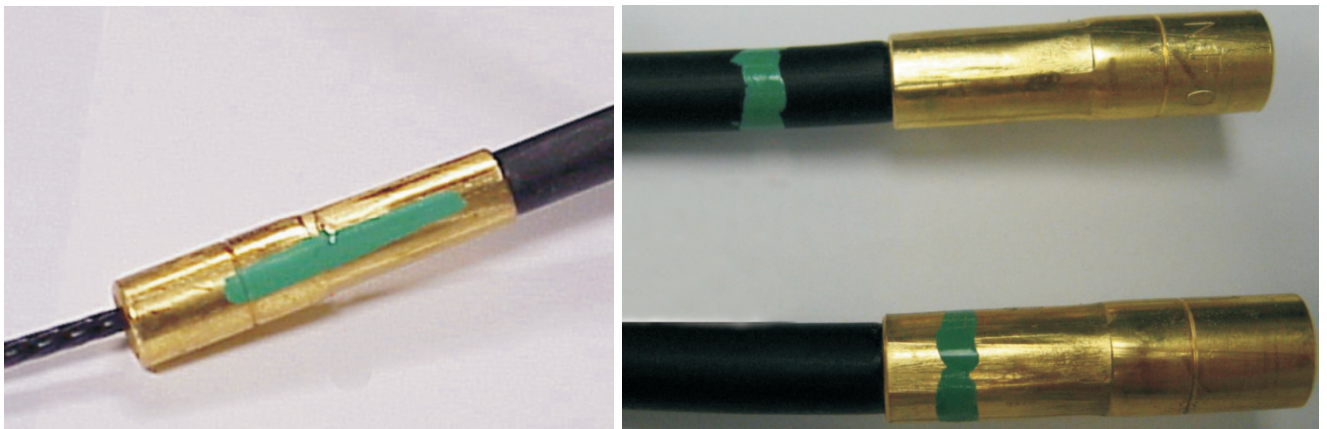
45171

Corrected cables have been marked on the outer housing at the engine end to signify that the inner core wire has been changed.

Various markings to indicate a corrected cable

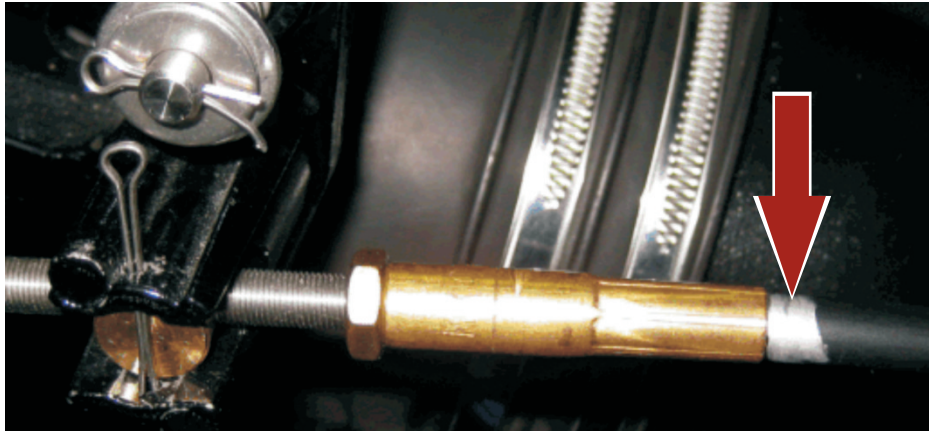
45170

Boat builders have been painting a silver stripe around the cable behind the brass ferrule at the engine end of the cable to signify that the inner core wire has been changed. Regardless of the color used on the outer cable housing, the inner core wire is identified with a green or blue paint dot on the end.

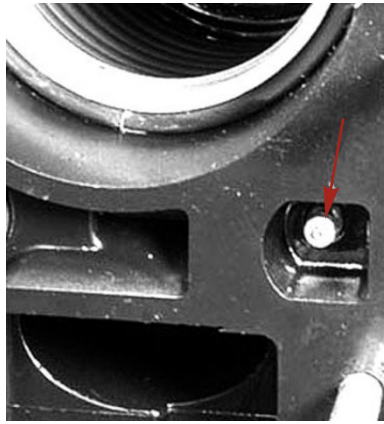
Core wire end

6. Pull the core wire from the intermediate shift cable cavity in the bell housing.
