service bulletin

No. 94-3

Trim Gauge Reading Opposite

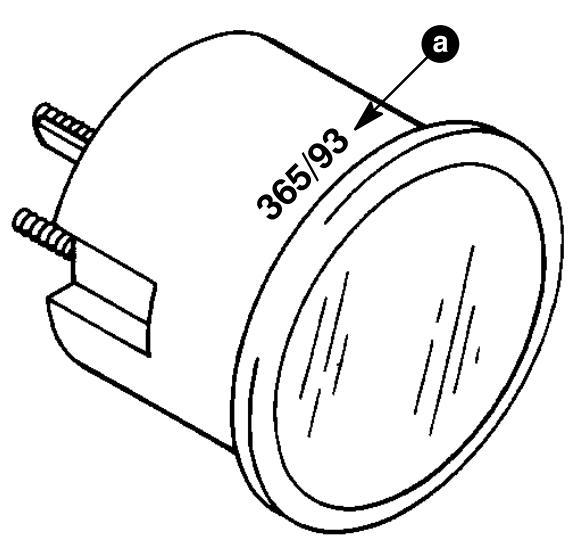
A number of trim gauges contained in the kits listed above have been manufactured incorrectly. Symptoms of the subject gauge are: the needle moves in the opposite direction of the outboard when trimmed in or out.

These kits/gauges are used on Mercury/Mariner 40 to 125-HP single-ram power trim systems. The affected gauges will have a date code of 365/93 and prior.

Replace trim gauges that have the listed date code of 365/93 and prior.
