Reference Voltage Circuit Optimax

MERCURY/MARINER 2001 MODEL YEAR 135 Thru 225 HP Optimax S/N 0T178500 and Up

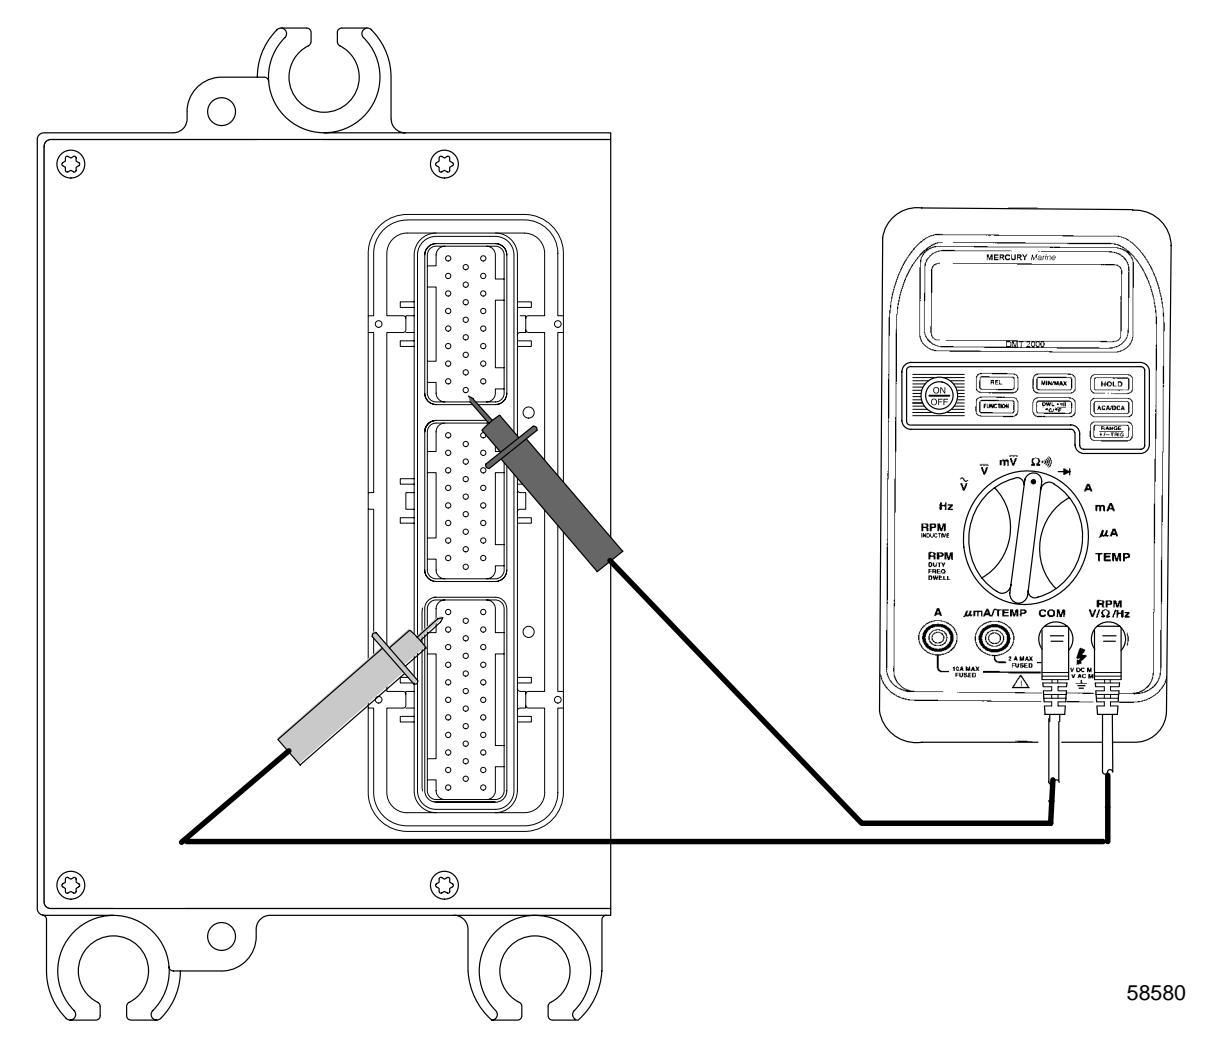
Failure of this circuit typically results in a very high idle speed 2000 to 4500 RPM. Another indication of circuit damage is abnormal readings on the Digital Diagnostic Terminal (DDT). **Example:** 32° F [0° C] on temp sensors, high voltage reading on the Throttle Position Sensor (TPS), and warning horn on engine start up.

To confirm failure make an ohms check between the two ECM pins shown below. The reading should normally be less then 1 ohm. High resistance or an open circuit indicates a damaged ECM. Before replacing the ECM, the wiring error must be corrected, or the replacement ECM may also be damaged.
