# **Service Bulletin**

#### Bulletin No. 2007-14

# Direct Injector Service and Test

Models Covered	Serial Number Or Year
1.5/2.5/3.0 Liter OptiMax	1998 and Newer
225/250 Pro XS	S/N 0G590000 and Above

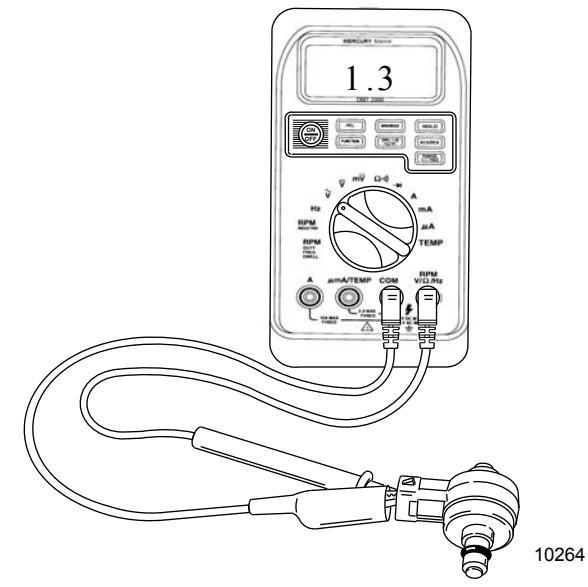
1.0 - 1.6 ohms between the two connector pins

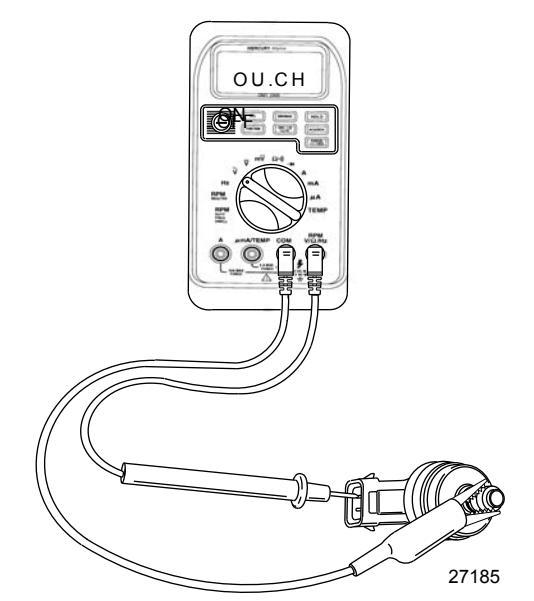
Current service literature indicates that there should be no continuity between the direct injector connector pins and engine ground or the metal housing of the injector. Direct injectors that have an ohms reading from each connector pin to ground greater than 1000 ohms will operate correctly and do not need to be replaced. For best results, check the direct injector for continuity to ground when the injector is near operating temperature (engine warmed up).

1000 ohms or greater between each pin and ground

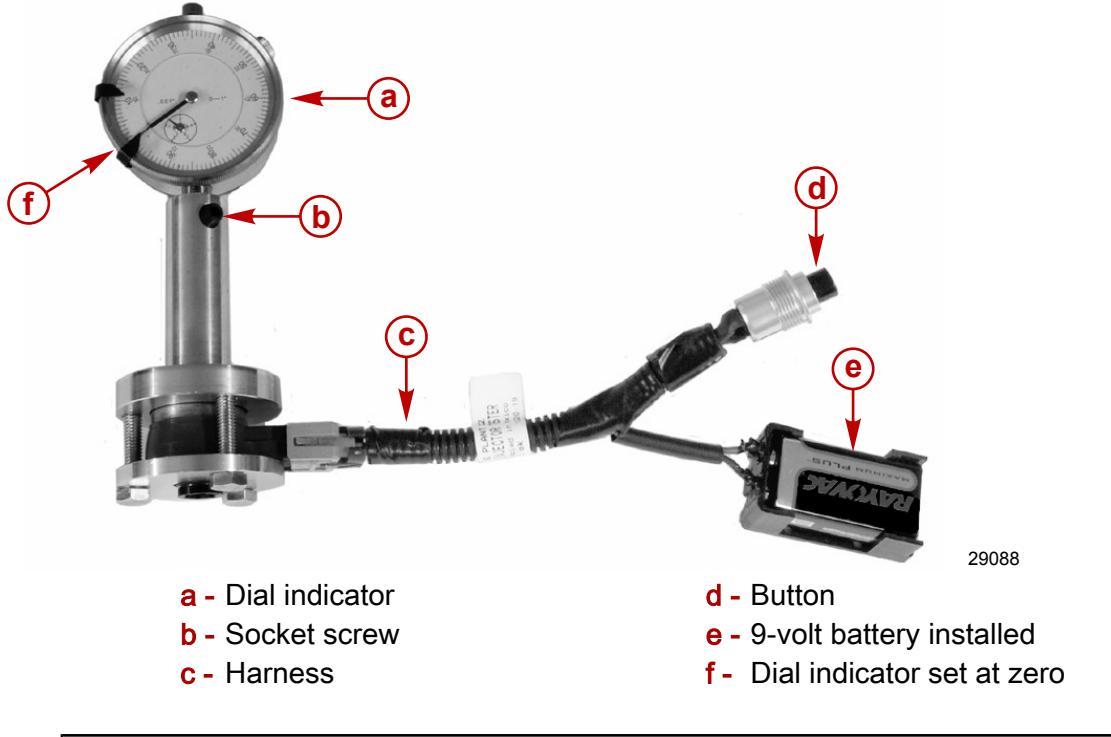
In most cases, if the pintle has reduced opening, it is caused by debris being trapped between the pintle and pintle seat. If pintle opening is below specifications, the injector should be replaced.

Direct Injector Specification	
Direct injector pintle movement	0.020 - 0.031 mm (0.008 - 0.012 in.)

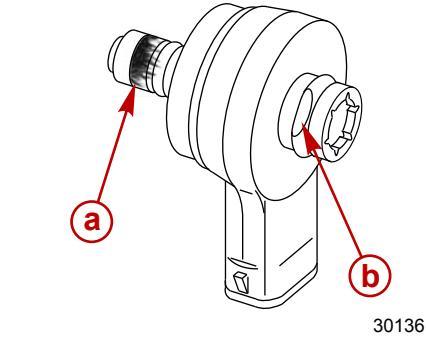
The condition of the carbon dam and O-rings on the direct injector may cause a misfire condition. Check for blow by past the carbon dam. If there is carbon on the injector housing side of the carbon dam, the carbon dam should be replaced.

- a Carbon dam showing blow by
- b O-ring (fuel rail) end showing damage/cut

Check the O-ring at the rear (fuel rail) end of the injector for cuts or damage. Both the O-rings and carbon dam are included in seal repair kit P/N 804875. See service manual for repair procedure.

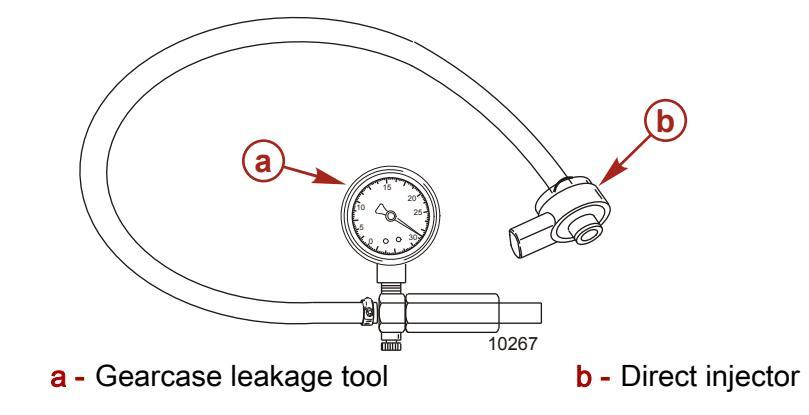
- Pump up the leakage tool to indicate 172.4 206.8 kPa (25 30 psi).
- Direct injector should not leak down more than 3.5 kPa (1/2 psi) in one minute.
- If injector does not meet the above specification, replace injector.
