service bulletin

No. 90-6

Shift Plate Inspection

All MCM V6/V8 Alpha One or Bravo One or Bravo Two Engines Serial Number 0C858947 - 0C877307

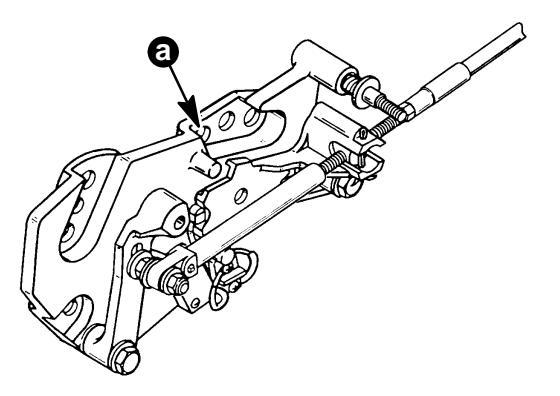
When servicing these engines, check to see if shift plate is tight against exhaust elbow in area of bolt (a) shown in Figure 1.

If plate is not tight against elbow, remove plate. File enough material off of locating pin (a) until it is flush with plates mounting surface (b). See Figure 2. Repaint bare metal. Install plate back on elbow. Torque bolts to 100 lb. in. (11 N·m).
