Service Bulletin

TDI 3.0L V6 Incorrect Thermostat

TDI 3.0L V6 – See included engine serial number listing

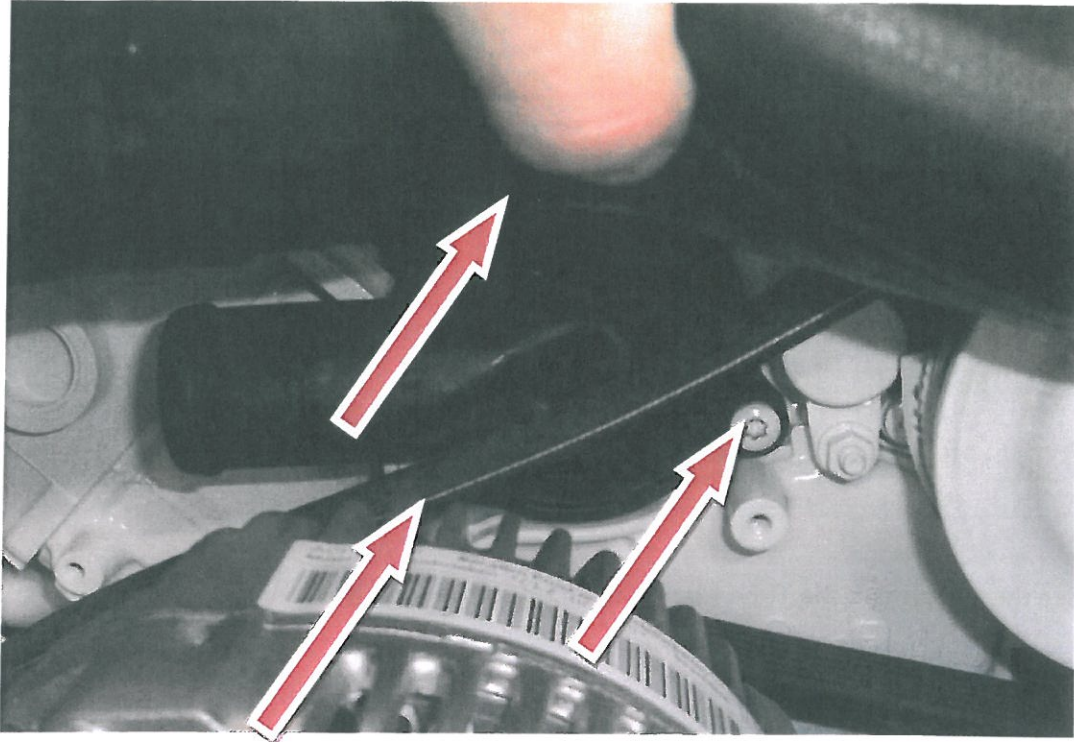
Step 5 – Remove the 3 screws attaching the thermostat housing to the engine block.

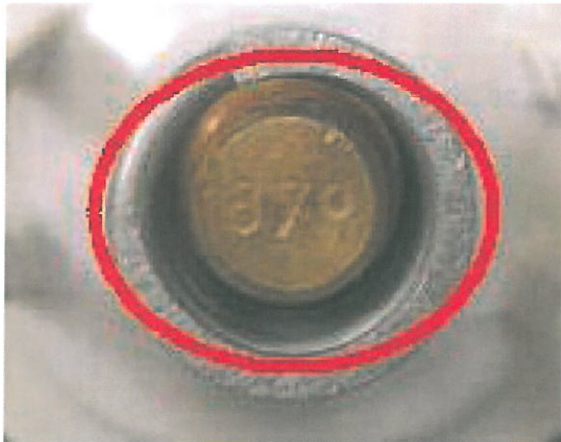
Step 6 – Inspect thermostat assembly

The temperature rating is stamped on the end of the thermostat. The thermostat must be stamped 70°.

If the thermostat is stamped 87°, then the thermostat assembly must be replaced, P/N 06V 121 111.
