# **Service Bulletin**

#### Bulletin No. 2007-14

# Direct Injector Service and Test

Models Covered	Serial Number Or Year
1.5/2.5/3.0 Liter OptiMax	1998 and Newer
225/250 Pro XS	S/N 0G590000 and Above

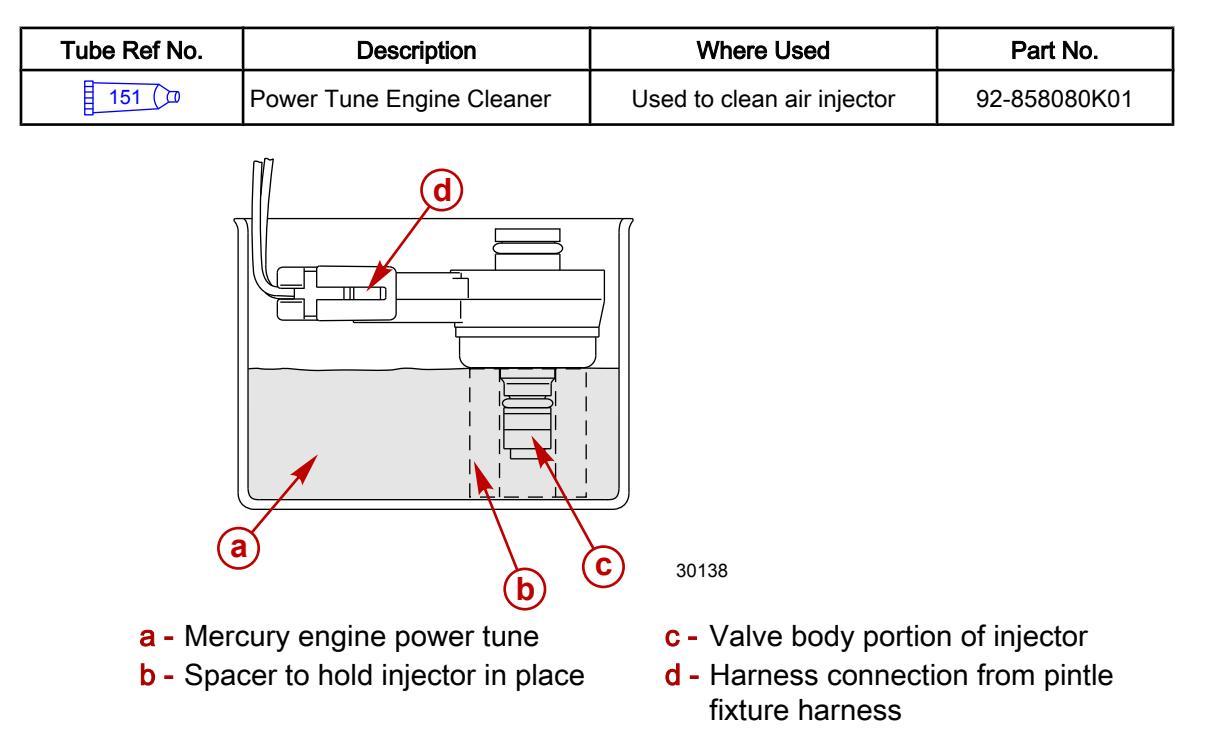
Place air injector in a clean solution of Power Tune Engine Cleaner P/N 92-858080K01 at room temperature. Place the valve body portion of the air injector in the cleaning solution (see picture following). Use a spacer or stack of washers to keep the injector positioned so only the valve body portion of the injector is in the cleaning solution. Soak the direct injector for 12 hours. When the injector is first placed in the solution, operate the injector using the pintle opening test fixture harness and switch assembly. Repeat this process after 6 and 12 hours of the soak period.
