No. 90-17

## A. REPLACEMENT OF GIMBAL HOUSING STUDS JUST BELOW THE INNER TRANSOM PLATE ENGINE SUPPORTS ON ALPHA ONE GENERATION II TRANSOM ASSEMBLY

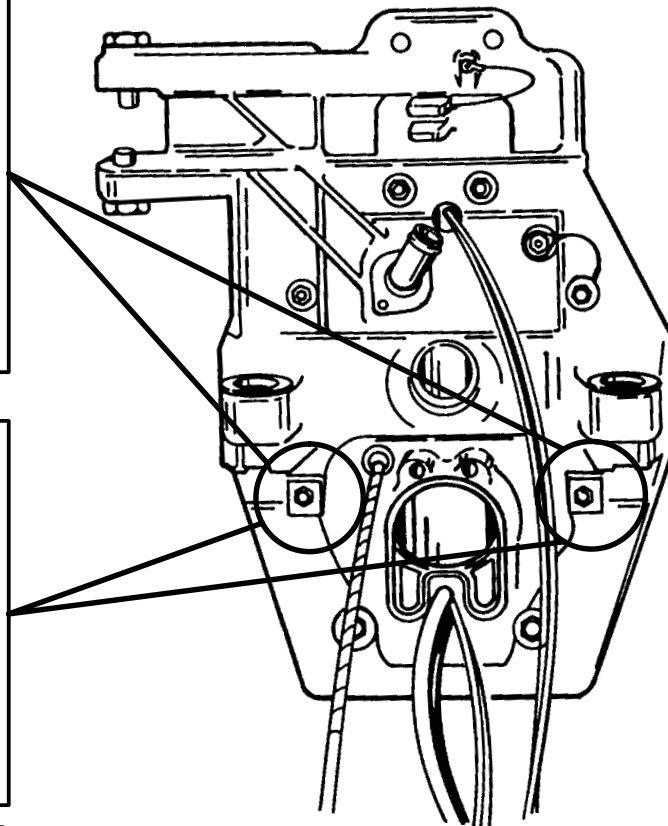
The studs just below the inner transom plate engine supports are too long and may rub on the lower exhaust pipe causing it to wear through.

b - 4-1/4 in. (108mm) Long Bolts Lockwashers and Square Flat Washers (2)

Replace studs-washers and elastic stop nuts (a) with bolts-lockwashers and square flat washers (b) as shown, and torque to 20-25 lb. ft. (27-34 N.m).
