Service Bulletin

Bulletin No. 2007-64
CMD 2007-04

QSD 2.0 Turbocharger Oil Supply Pipe

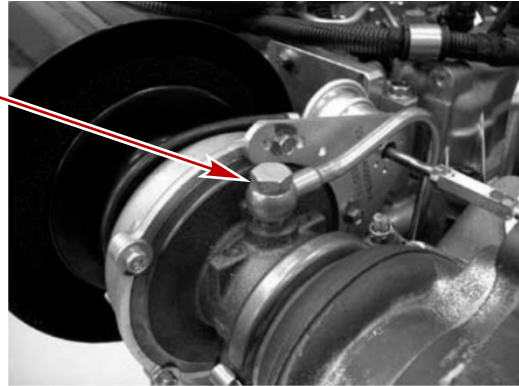
32075

Hollow bolt

2. Close the seacock, if equipped, or disconnect and plug the seawater inlet hose.
3. Drain the seawater system.
4. Drain the engine coolant from the engine.
5. Remove hollow bolts and related sealing washers from turbocharger and crankcase connections. Discard the sealing washers.

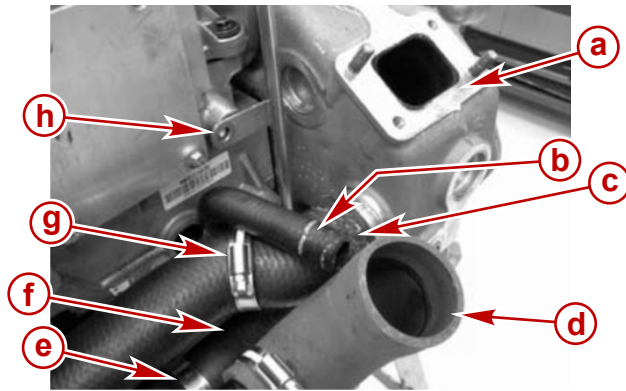
32076

- a** - Turbocharger flange
- b** - Oil return hose
- c** - Exhaust manifold seawater hose
- d** - Compressor outlet hose
- e** - Hose clamp
- f** - Heat exchanger seawater hose
- g** - Hose clamp
- h** - Location of bolt for oil supply pipe bracket

13. Disconnect the ends of the seawater hoses.

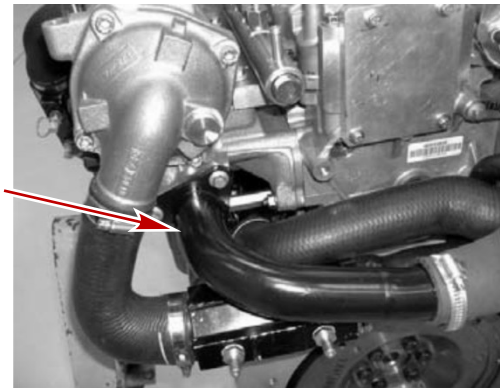
32077

Air crossover pipe

14. Remove the three bolts from the triangular flange attaching the air crossover pipe to the after cooler assembly. Remove crossover pipe and discard the gasket.

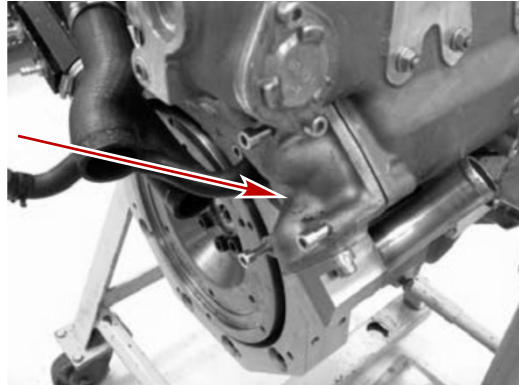
32078

Heat exchanger end cover

- Remove the four bolts attaching the end cover to the heat exchanger. Remove end cap and discard the O-ring.
