Field Campaign on 8.2 Inboard ECT Engines

Inboard Models	Serial Number
8.2 Horizon DTS ECT	1A350802-1A353889
8.2 H.O. DTS ECT

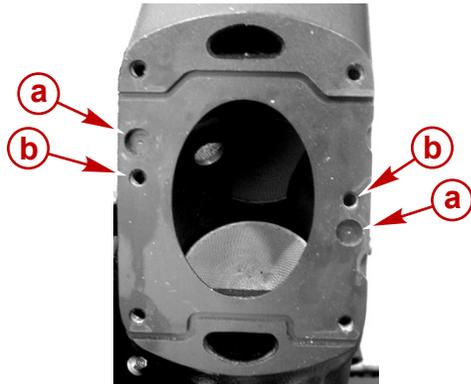
ECT exhaust collector mating surface

- Inspect the mating surfaces before installing the new exhaust elbow riser. Clean the mating surface of the exhaust collector, if necessary.

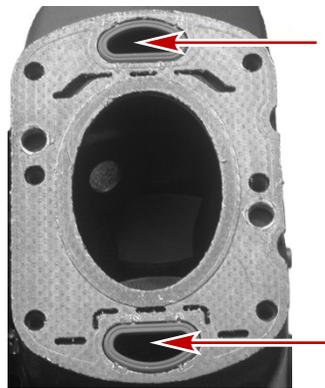
Water ports aligned

- With the dowels fully seated in the dowel holes, the water ports on the exhaust collector should align with the water port gaskets. If misaligned, rotate the gasket 180°.

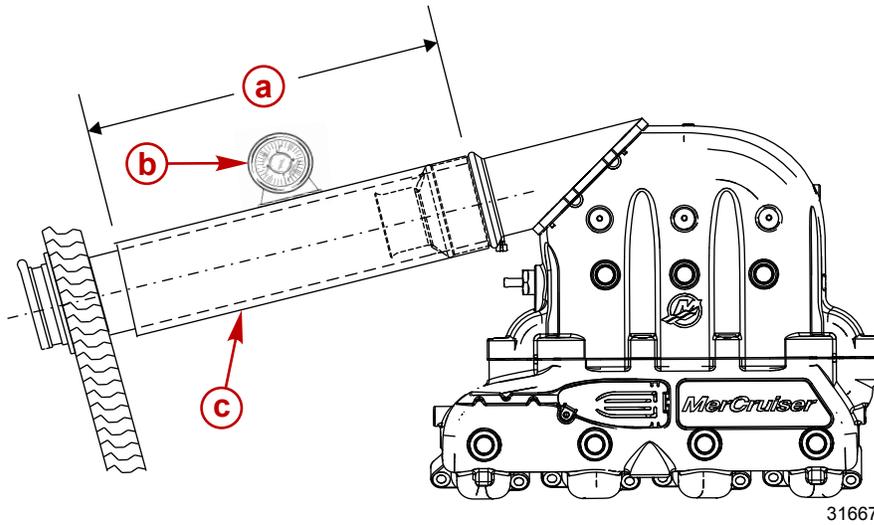
NOTE: Measure the marine grade exhaust tubing aft of the elbow to ensure the minimum distance of 457 mm (18 in.). If this dimension is below the specification contact your boatbuilder.

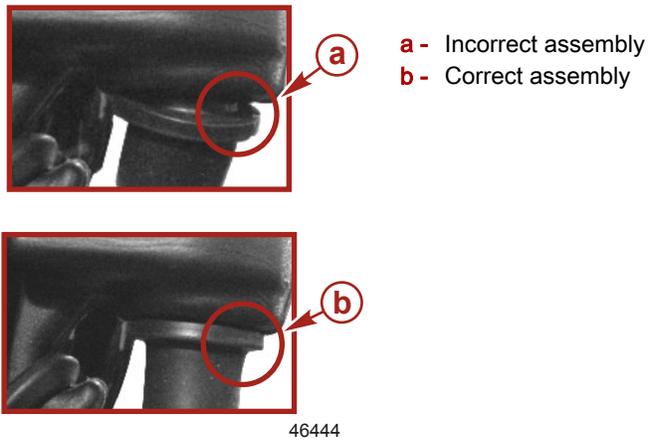
8. Inspect the grommet-to-reservoir area to assure there is no side-load pulling on the grommet. The grommet should be relaxed and fully seated against the reservoir. The hose should not be bent or kinked. Position the T-fitting portion of the assembly as necessary to ensure proper assembly.
