Zeus Guardian Strategy and Updates for SC2.5

Notice
Revised April 2017. This bulletin supersedes the previous bulletins, numbers 2013-66 and 2013-66R1 dated June 2013 and December 2014.

Models Covered	Year
Zeus KH Pods	2012-2016

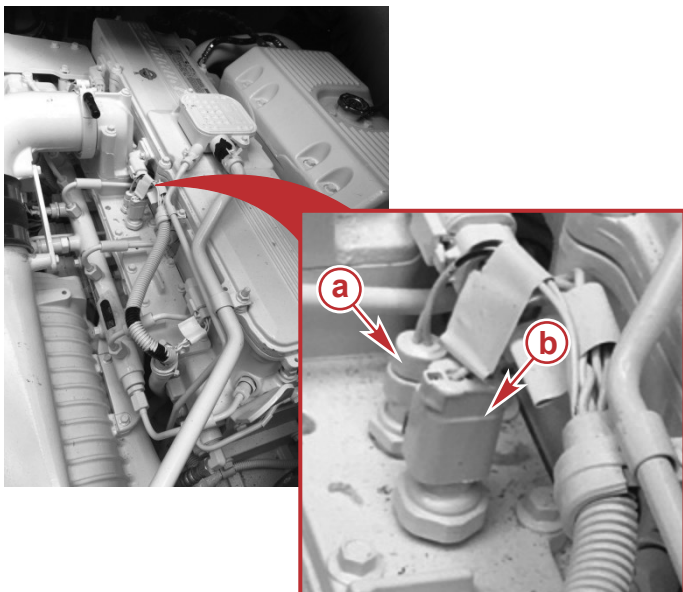
63021

- a - Intake manifold temperature sensor
- b - Boost pressure sensor

- a. Disconnect the intake manifold temperature sensor.

- b. Ensure that a fault has occurred by viewing the VesselView screen for the fault indication. Alternatively you can observe CDS G3 in the module data screen. A module that is faulting will indicate so in the right hand column of CDS G3's module data. Ensure the Intake Manifold Temperature fault you are triggering shows up in the starboard or port SIM.

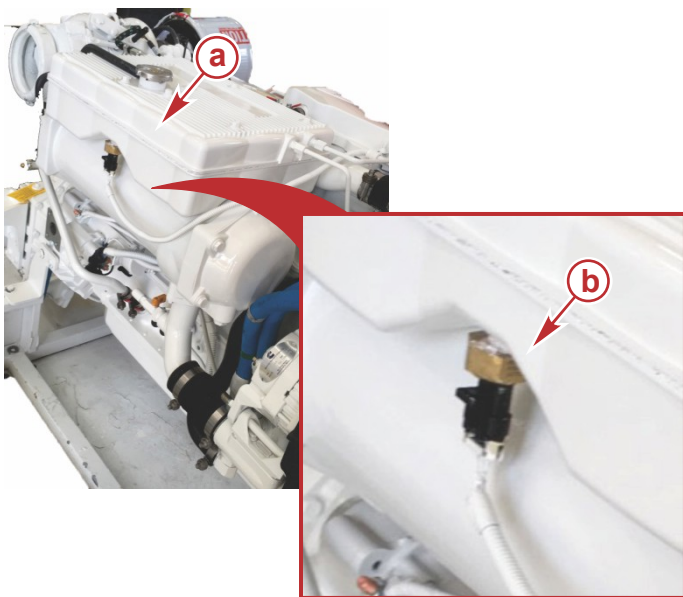
63026

- a - Reservoir
- b - Coolant level sensor

- a. Disconnect the coolant level sensor.

- b. Ensure that a fault has occurred by viewing the VesselView screen for the fault indication. Alternatively you can observe CDS G3 in the module data screen. A module that is faulting will indicate so in the right hand column of CDS G3's module data. Ensure the Coolant Level Sensor fault you are triggering shows up in the starboard or port SIM.
3. The audio warning system should sound for six one-second intervals.
4. Turn the keys off and pull the electronic remote control handles back to reverse wide open.
5. Turn the keys on again and verify the presence of the faults and the audible caution horn—6 beeps.

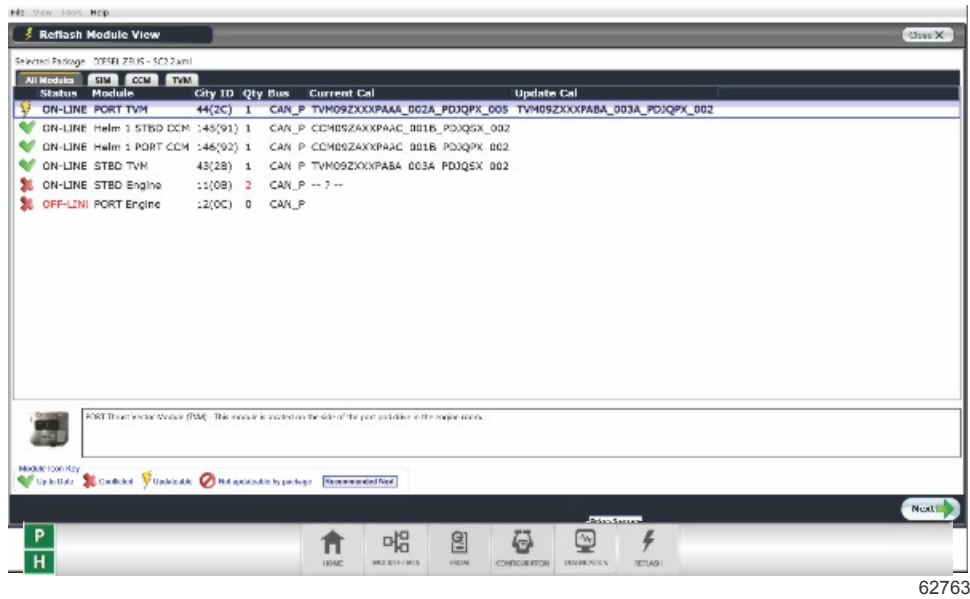
62763

- As each SIM is flashed, the number of modules that appear on the starboard City ID (11 decimal, 0BHex) will increase by one. As the quantity of the starboard SIMs goes from one to two, note the display will show a red X icon next to the modules that have been completed. This is a normal part of the procedure.

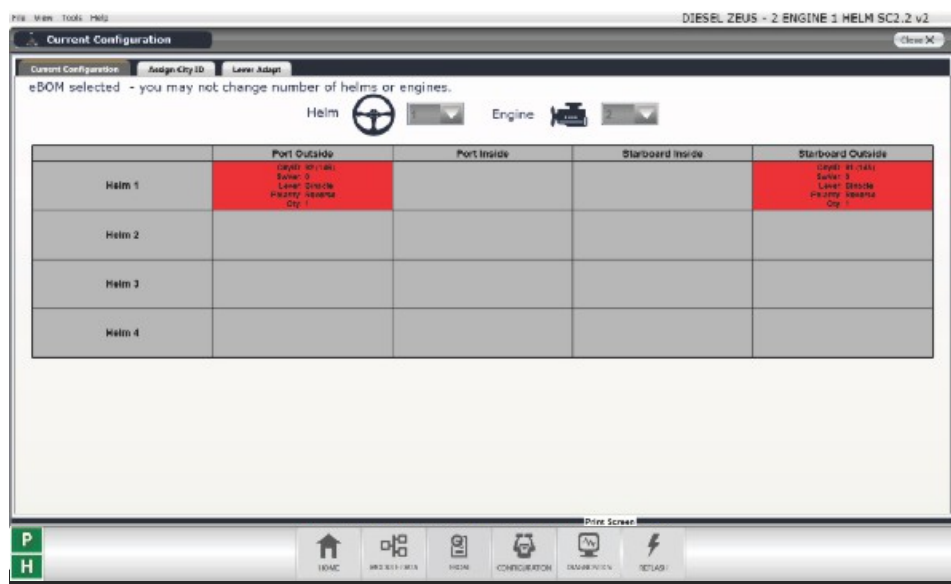
62759

6. Each module City ID corresponds to its helm and engine.

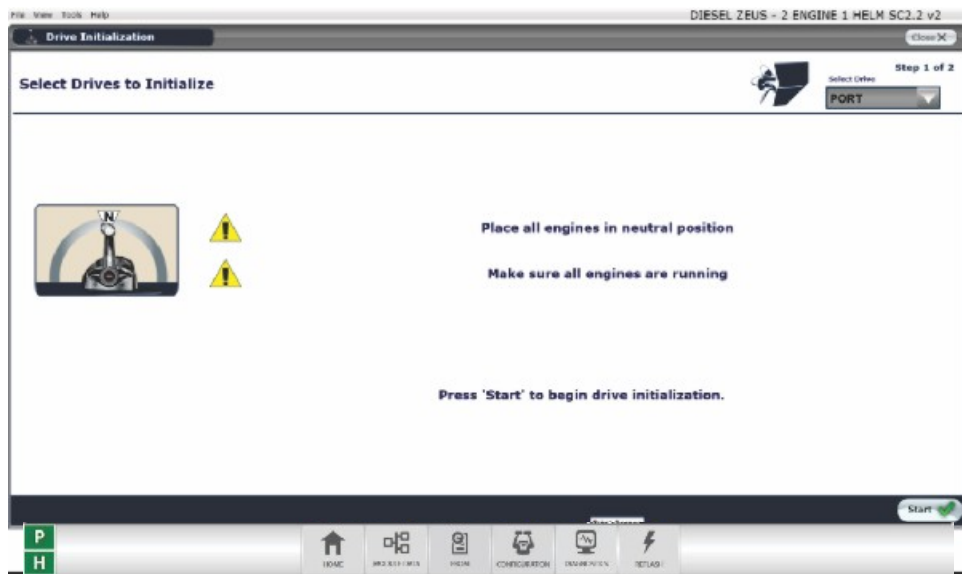
62764

When a TVM is reflashed, the mechanical stop information is lost. Mechanical stop information must be restored using the Drive Initialization procedure.

1. Start the engines.
2. Go to Configuration and select **Drive Configuration** in CDS G3.
3. Select **Drive Initialization** and follow the on-screen directions to complete the initialization of each pod drive.
