PCM 09 Calibration Update—Optional

Models Affected

All ECT models equipped with a malfunction indicator light (MIL) or check-engine light and Non-ECT 8.2L models. Models with other brand gauges with check-engine lights will also be included within the serial number ranges.

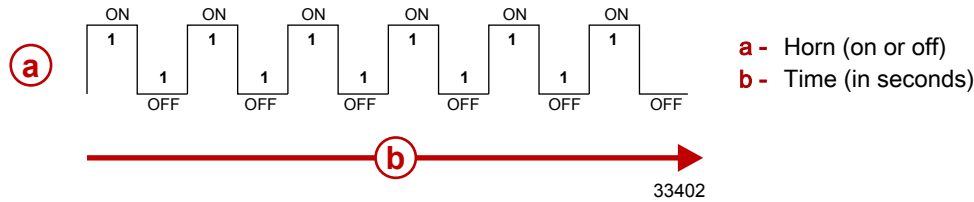
Caution

If a caution state is detected, the audio warning system will sound for six one-second intervals.

Most faults cause the warning horn circuit to activate. How the warning horn activates depends on the severity of the problem.

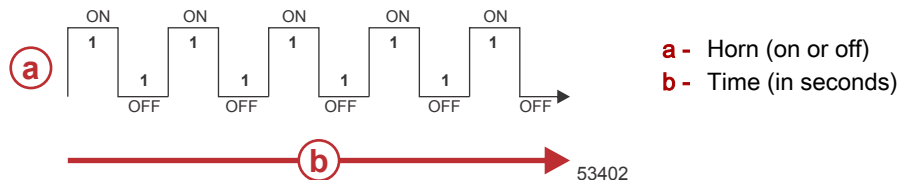
Nonconfigured Alarm—DTS Only

If the helm has not been properly configured using the G3 service tool, the audio warning system will sound for five one-second intervals.
