Bulletin No. 2007-65 CMD 2007-05

Required QSD 2.8 and 4.2 Fluid Cooler Cover Plug Replacement and Anode Inspection

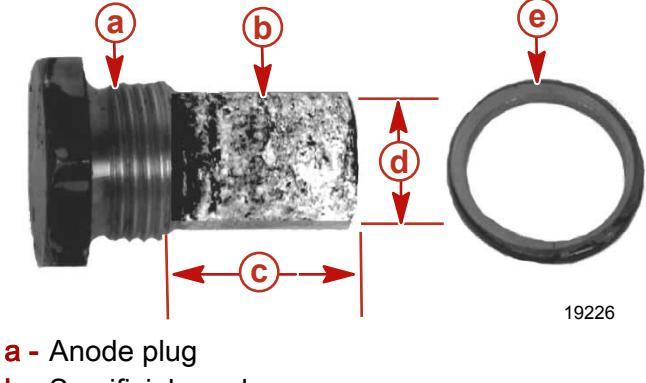
- 8. Remove the anode plug assembly. The anode is the larger of the two plugs in the end cover of the fluid cooler. Verify that there is an anode installed on the plug.
- 9. Inspect and measure the anode. Compare the measurements to the specifications for a new sacrificial anode assembly.

- b Sacrificial anode
- c Length
- d Diameter
- e Sealing washer

Sacrificial anode	Measurements (new)
Length	19 cm (3/4 in.)
Diameter	16 cm (5/8 in.)

IMPORTANT: Replace sacrificial anodes if eroded 50% or more. Cummins MerCruiser Diesel strongly recommends avoiding the use of anodes from another manufacturer. Refer to your Cummins MerCruiser Diesel Authorized Repair Facility for additional information.

10. Install the new anode plug assembly into the aft end of the cooler cover if the anode is missing or is consumed more than 50%.

11. Torque the anode plug to specification.

Description	Nm	lb. in.	lb. ft.
Anode plug	53	-	39
