V-6 POWER TRIM MOTOR HARNESS

Models Affected

MERCURY/MARINER
135 THRU 250 HP CARB/EFI/OPTIMAX
0G303046 THRU 0G803202

Advisory

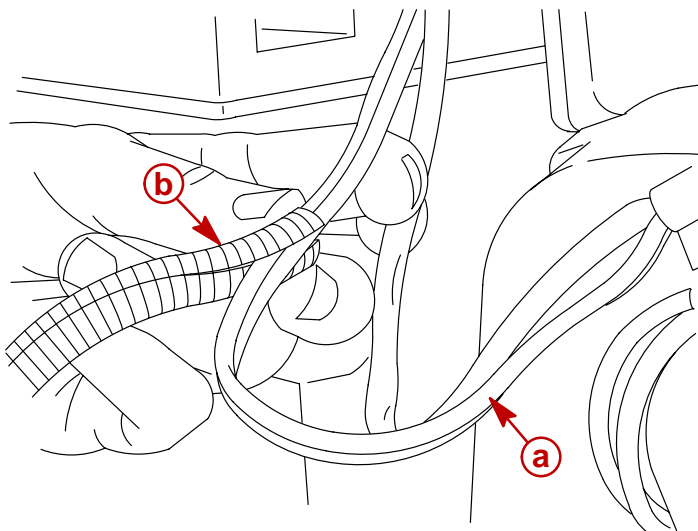
56920

In some isolated cases contact between the power trim motor harness and the bottom cowl has been reported by our Technical Account Managers. This condition over time could cause chaffing of the motor harness. When servicing outboards within this group, it is recommended conduit **P/N 32-828547353** be installed over the motor wires between the adapter plate and starboard clamp bracket. This will provide added protection against chaffing. **DO NOT** include the trim sender wire within the protective conduit. Sta-strap the conduit to the trim sender wire.

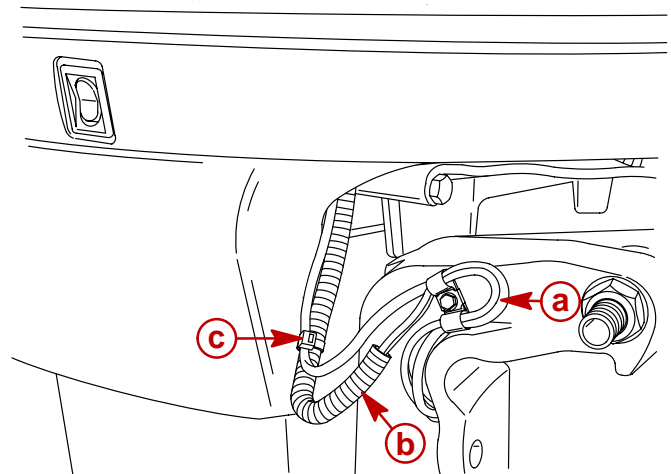
56922

- a - Power Trim Harness
- b - Conduit P/N 32-828547353
- c - Sta-Strap P/N 54-816311
