92-5

REQUIRED WARNING DECAL INSTALLATION

Models Affected

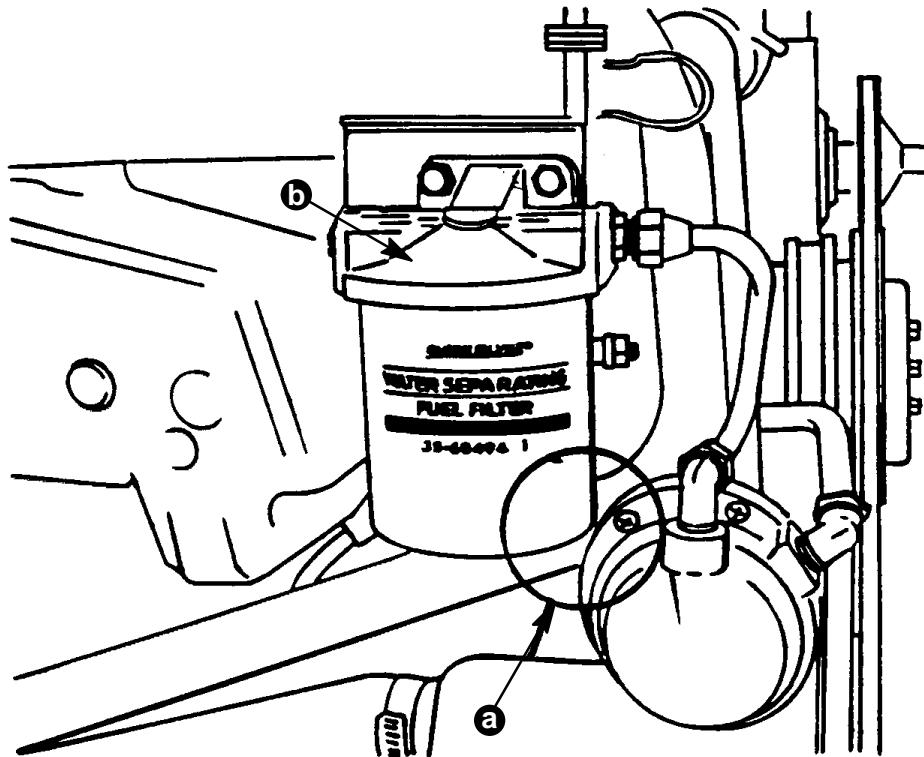
71229

If too long of a fuel filter is installed on these engines, it could come in contact with the fuel pump. After a period of time, a hole will be worn into the bottom of the filter (a) which in turn will allow fuel (gasoline) to leak into the bilge of the boat.

a - Filter may wear through in this area
b - Dealer to place warning decal here

Look for WARNING decal on Fuel Filter Base Assembly at location (b) as shown in the drawing. If the decal isn't there, one must be installed.

Install the WARNING decal on any engine you have in stock. If the boat has been sold, please contact your customer and perform this service on his engine(s). Also, please make sure that the short filter P/N 35-805269--1 has been installed as outlined in Service Bulletin 91-27. When an engine is registered at Mercury Marine, our computer will check to see if the decal has been installed. If our records do not show that the decal was installed, the customer will be contacted by letter with a campaign card enclosed. Please install the decal, then use the campaign card to file for warranty.

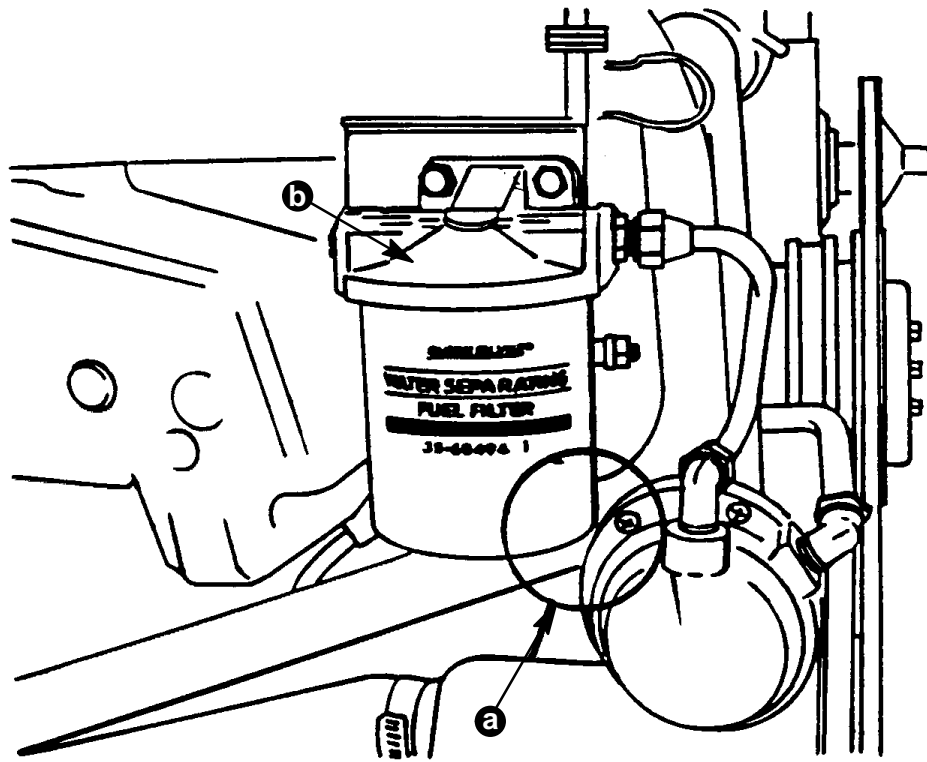
71229

If a filter longer than 3-3/4 inches (95 mm) is used, it is possible that the filter could contact the fuel pump. This contact could result in a hole being worn through the filter causing a fuel leak. A leak would create the potential for a fire or explosion if an ignition source is present.

- a - Filter may wear through in this area
- b - Dealer to place warning decal here

Attached is an illustration of a warning decal. Part Number 37-805349. This decal should be applied to your engine by your MerCruiser dealer as a reminder that a special filter is required.
